# ISSUE 548 **BULLETIN**

## REPAIRING PLASTERBOARD AFTER AN EARTHQUAKE

June 2012

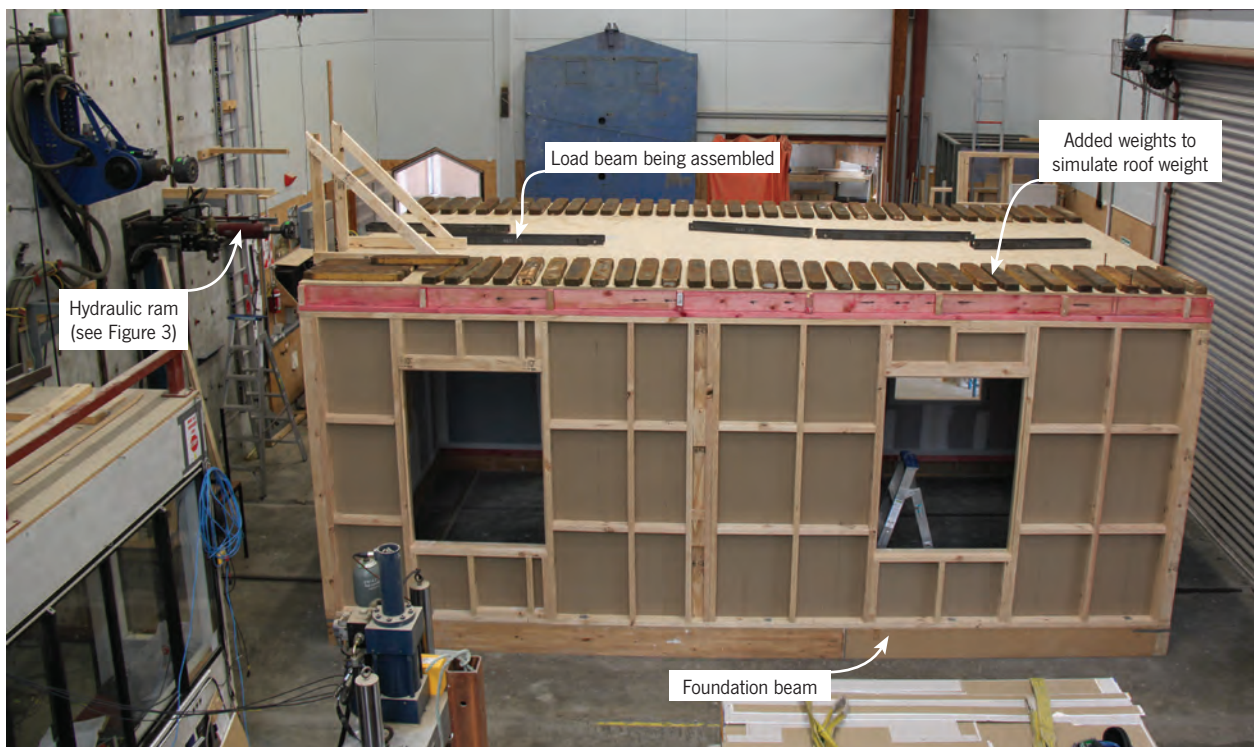
Figure 1. Test building

**2.0.1** BRANZ constructed and tested a single-room single-storey building (Figure 1). The building was nominally 2.4 m high and incorporated windows and doors and two short internal walls (one in each direction) (Figure 2). It had plasterboard-lined light timber-framed walls and a timber-framed plasterboard-lined ceiling with a 20 mm thick particleboard flooring on top. This flooring served to ensure that the

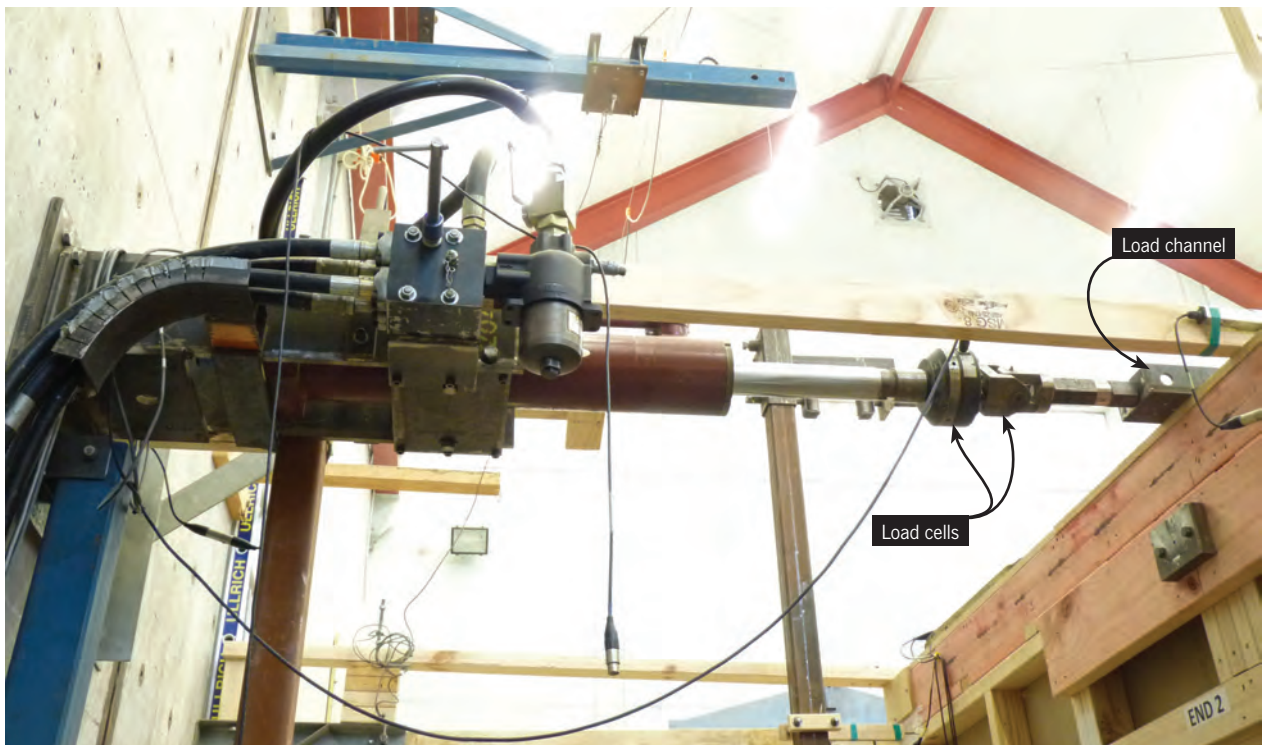
Figure 3. Hydraulic ram loading the test building via load cells

**2.0.4** Force was applied with the hydraulic ram, which moved a load beam connected to the particleboard flooring at roof level (Figure 3). The load beam ran the full length of the building and was located at mid-width of the building. Thus, the building 'roof' moved horizontally, imposing racking deformations on the side walls similar to the deformations that are imposed by earthquake loading in this direction.

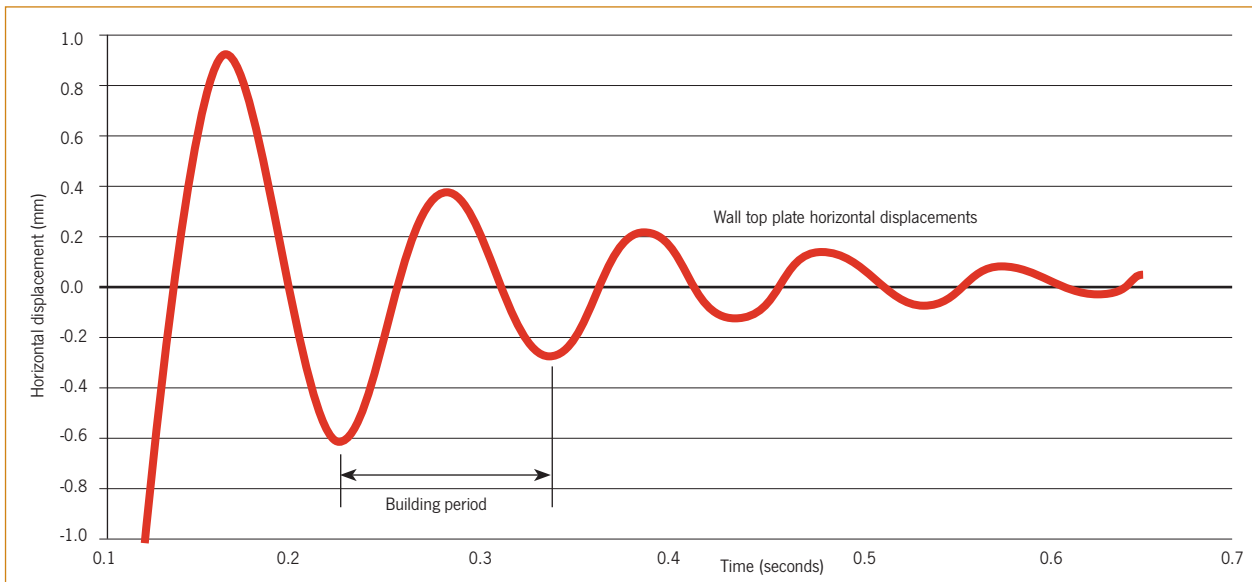
Figure 4. Top plate displacements measured in a building natural frequency test

**3.2.1** At various stages in the test programme, the building 'roof' was moved horizontally by a few millimetres and then quickly released, causing oscillation in a decaying vibration (Figure 4). The building's natural frequency and damping were able to be determined from these plots using standard formulae.
