ISSUE 551 BULLETIN

LEARNINGS FROM THE CANTERBURY EARTHQUAKES

August 2012

This bulletin gives an overview of the learnings that came from examination of damaged buildings.

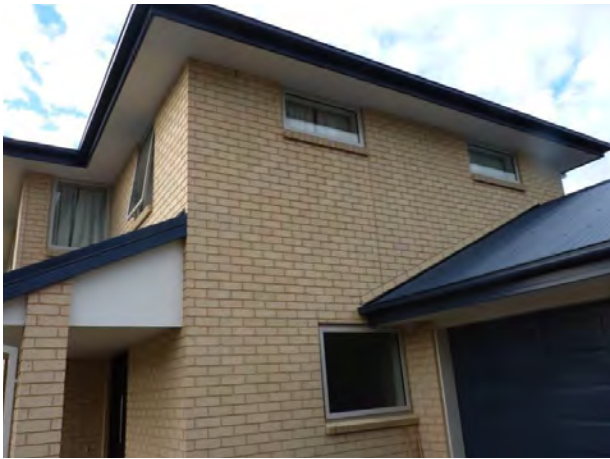
Careful design and construction meant this 2 storey masonry veneer house performed well, with only minor damage inside.

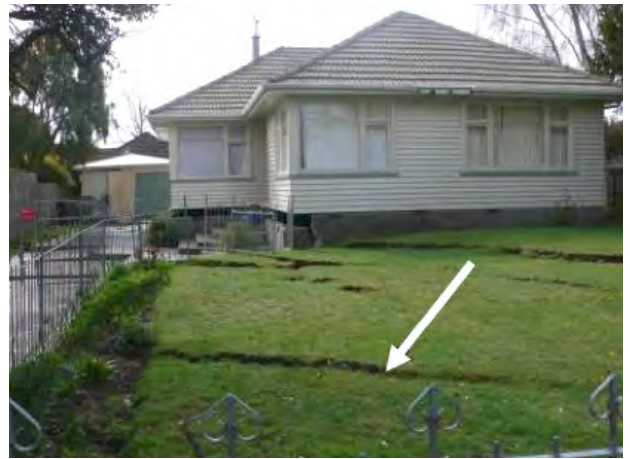
Lateral spreading is clearly visible in the grounds around this house.

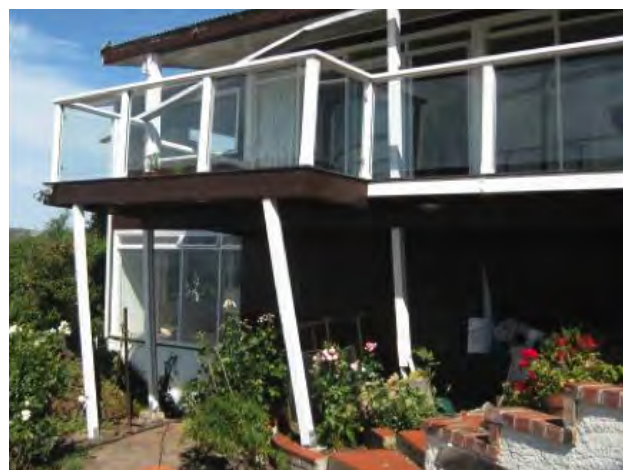
4.0.3 The hill suburbs were affected most by ground shaking and distortion, with many examples of ground slumping/sliding affecting houses.

There were many examples of ground slumping/sliding affecting houses.

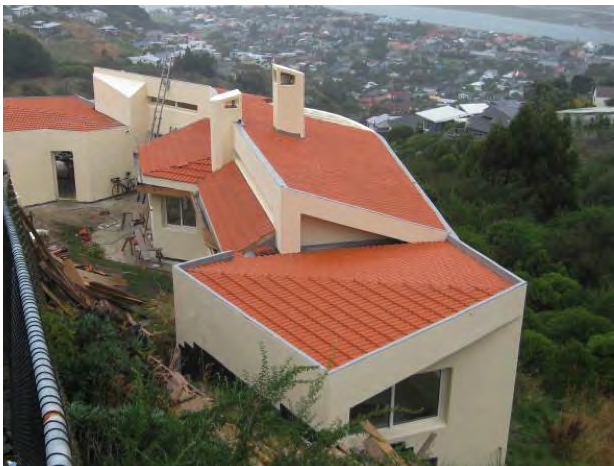
Plan irregularity increases the risk of damage.

6.7.4 Irregularly shaped houses generally fared worse than regularly shaped houses.

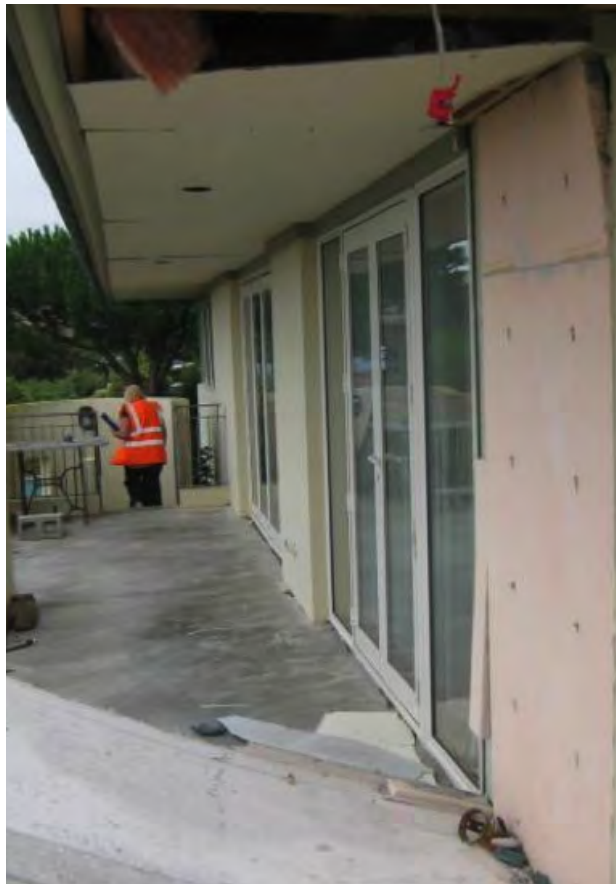
The connections failed on this precast concrete panel.

6.2.6 BRANZ saw some connection problems in houses built with precast concrete panels.
