Gypsum Plasterboard Lined Partitions in Commercial Construction Update

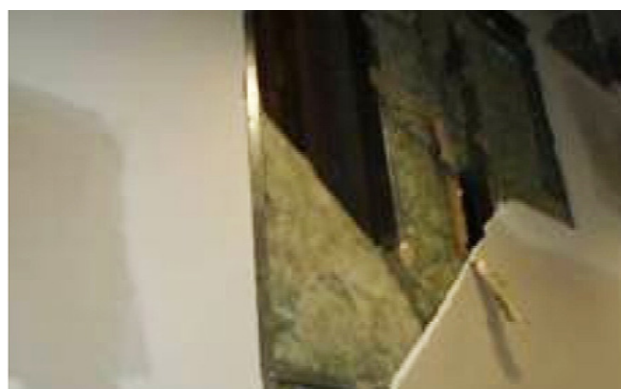
The Canterbury earthquakes have resulted in significant damage to non-structural partitions in commercial buildings. Damage has been particularly pronounced where plasterboard-lined areas have been expansive and where linings have been continued past floor levels, such as in vertical shafts and stairwells in multi-level buildings. Common

damage has included cracked sheet joints, crushed sheet edges, fastener ‘pops’ and in some cases substantial sheet fracture and sheets dislodging from frames.

FIGURE 1: Substantial damage to non-structural gypsum plasterboard partition

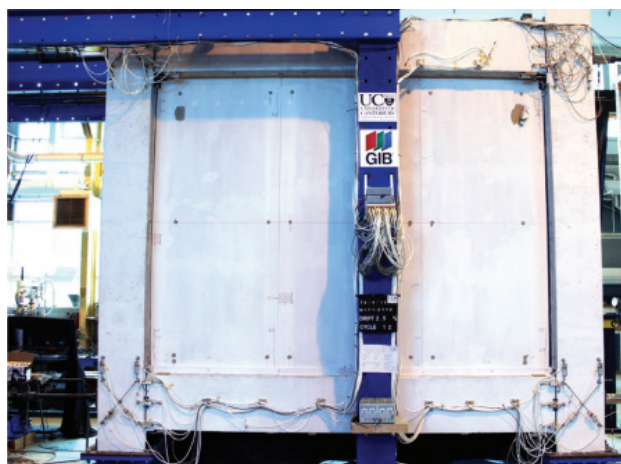
Testing at Canterbury University (Tasligedik et al, 2012) has shown that by simply incorporating regular relief joints, ‘low’ and even ‘no damage’ solutions for non-structural partitions can be designed successfully. ‘Shadow lines’ or ‘negative details’ at wall junctions and intersections with the main structure, and breaking up expansive areas with regular control joints, provides freedom for the non-structural elements to accommodate main structural movements.

Testing has shown that incorporating such details can result in ‘no damage’ at SLS and even ULS inter-storey drifts. Gaps can be arranged by simple calculation and can easily be made aesthetically pleasing or hidden with sealants or trim finishes.

FIGURE 2: Non-structural partition being tested at Canterbury University

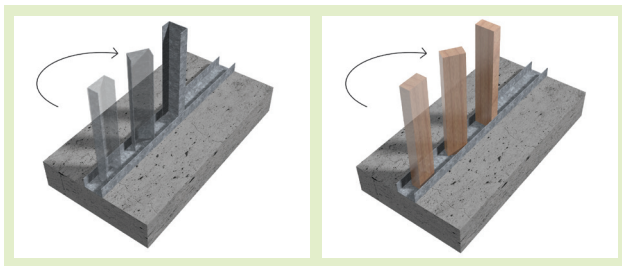
FIGURE 3: Framing details to minimise risk of post-earthquake damage

In order to protect plasterboard-lined partitions from damage, connections must be minimised and separation from the main structure must be provided so that seismic movements can be accommodated. Figure 3 shows the principle of constructing partition framing. Metal top and bottom tracks are used with friction-fit metal or timber studs. A standard nominally 90mm timber stud fits into a commonly available 92mm metal track. Plasterboard linings are fixed to studs but not to the top and bottom tracks.

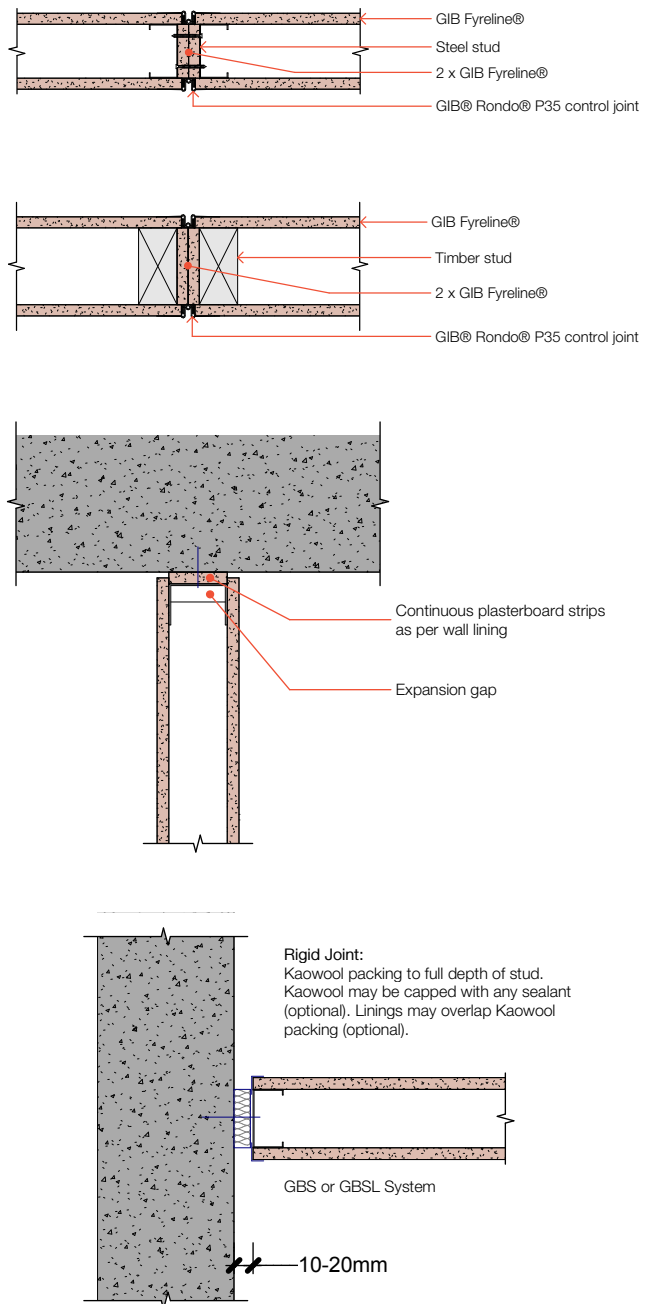
FIGURE 4: Simple plasterboard jointing details to minimise risk of post-earthquake damage

Figure 4 shows a number of already available details (Winstone Wallboards, 2006) that can eliminate or will significantly reduce earthquake damage to gypsum plasterboard lined partitions in commercial construction.

All details involve 'disconnection' from the main structural elements and a regular pattern of intermediate control joints.

Gypsum plasterboard packing strips can be provided behind joints to ensure on-going integrity of fire or noise control separations. Proprietary trims and finishes exist to create clean shadow lines which can be left, covered, or sealant filled depending on architectural preference.
