THE PERFORMANCE OF HOUSES AND GYPSUM PLASTERBOARD LININGS DURING THE CANTERBURY EARTHQUAKES

Hans Gerlich and Richard Hunt¹

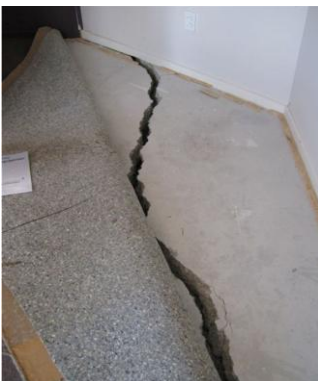
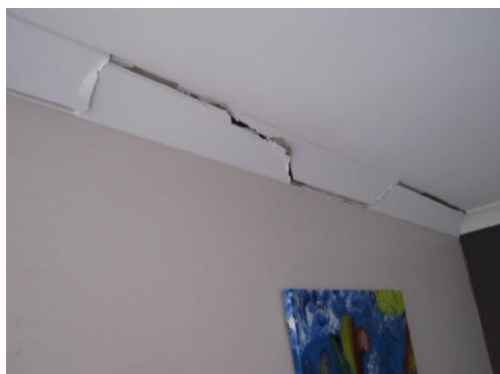
Damage on soft soils has been greatest to brick veneer homes on un-reinforced concrete slabs. Subsidence and lateral spread (ground cracks opening up) caused slabs to slump and break, and the rest of the structure to follow. The repair of many such structures is complex and expensive, if possible at all. Although older houses with concrete perimeter footings and timber floors on shallow piles suffered similar movement, they are often easier and cheaper to repair.

Broken residential un-reinforced concrete slab and consequential damage to internal linings due to lateral spread

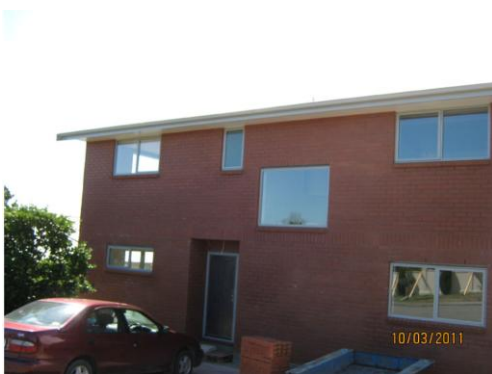
However, houses under construction provided important information. An example is a two storey brick veneer home located in the severely affected suburb of Mt Pleasant. This house was carefully designed by the building inspector / owner with designated gypsum plasterboard bracing elements clearly marked on the floor and installed in accordance with manufacturer's instructions. The plasterers were at work when the earthquake struck and plastered sheet joints were still fresh. Apart from expected shear failure of these joints, the house stood up very well.

Building inspector's Mt Pleasant home under construction lost some of its brick veneer, but performed well supported by gypsum plasterboard bracing systems.

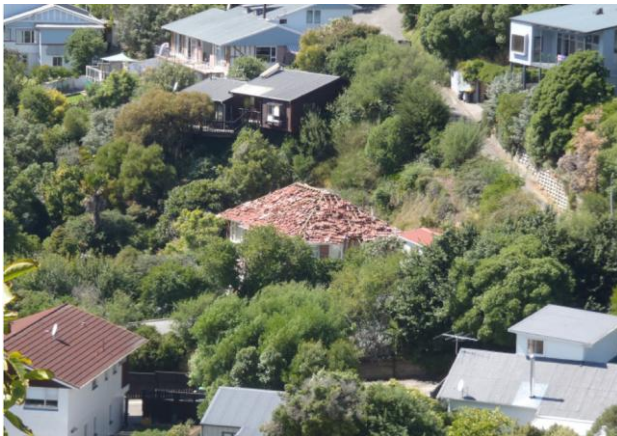
Houses with heavy-weight roofs were more prone to damage. In addition substantial loss of untied or poorly tied heavy-weight tiles was observed.

It is worth noting that significant damage has been observed to buildings with heavy claddings. A heavy-weight roof cladding increases earthquake demand by as much as 50% when compared with a light-weight roof. When wall and roof claddings are specified as heavy-weight the earthquake demand can more than double compared with light-weight claddings.
