Post-Earthquake Performance of Sheet Bracing Systems

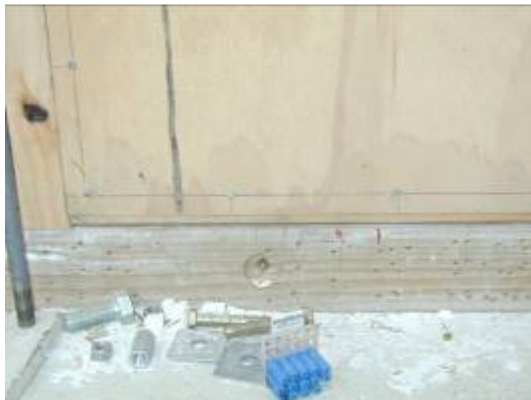
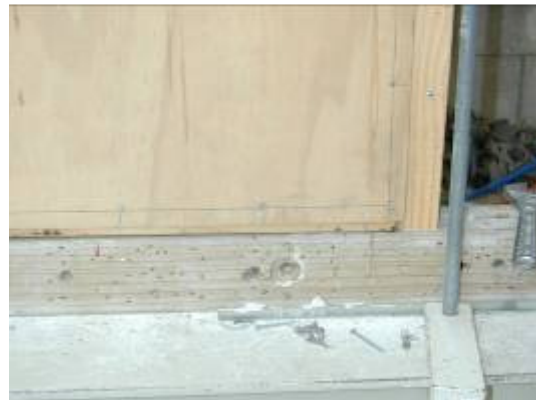
The behaviour of the plywood bracing element shown in Figure 7 is similar to that of the plasterboard bracing element. The stiffness of the element at half the serviceability design load after cycling to ± 36 mm is approximately 25 % of the original stiffness. Little or no damage to the bracing element was apparent after testing.

Plate 2
Bottom of Plywood Bracing Element After Testing

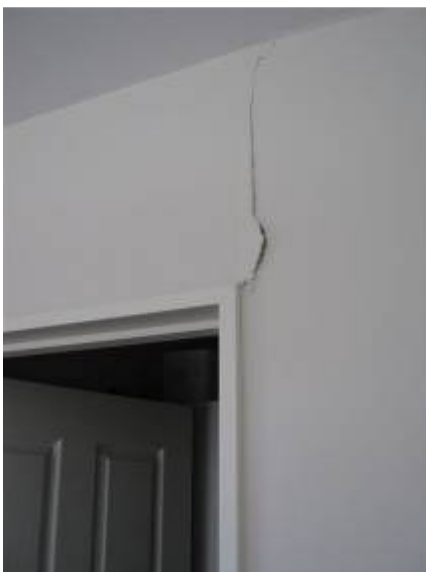
The formation of cracks in the linings as a result of earthquake movement is probably the most visible form of damage to plasterboard bracing elements. Cracks have often propagated from the corners of doors and windows. If there is a joint between the plasterboard sheets adjacent to the corner, then the crack will follow that joint. However if the plasterboard sheets are joined away from the corners of doors and windows (as suggested for best trade practise), then a diagonal crack forms in the plasterboard that extends from the corner into the field of the sheet.

(a) Crack of Joint above Door

- (ii) If cracks have appeared in the field of the lining, then the lining should be removed and replaced. If cracks are along the joints then the old compound can be scrapped out, the linings refastened to the framing and new joint compound and tape placed in the joint. If an overlay is to be used, then no special attention needs to be paid to the old lining.

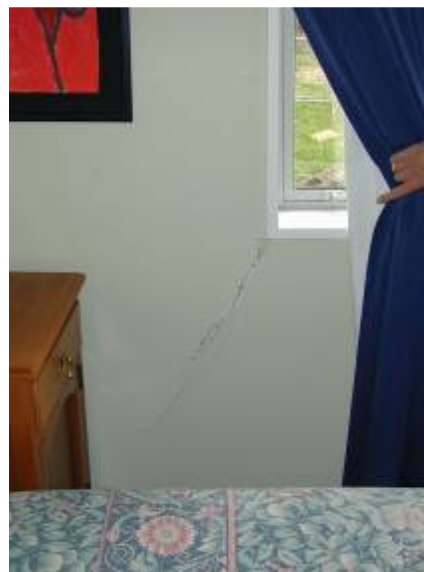
(b) Diagonal Crack at Corner of Window

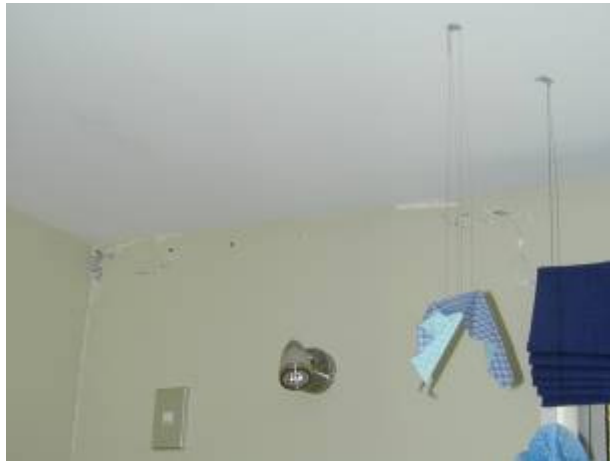
Lining fastener movement as a result of earthquake forces can be easily identifiable or hardly visible. The movement can be such that fracture of the plasterboard along the line of fasteners can occur.

Plate 4
Fracture of Plasterboard along a Line of Fasteners

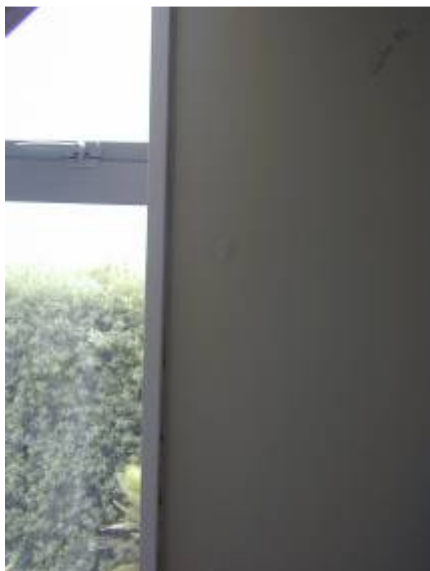
Fastener movement can result in popping of fasteners. In some cases this movement is readily identifiable but in other cases it is hardly distinguishable.

(a) Visible Fastener Movement

- (iii) The bracing element should be re-fastened with appropriate fasteners. **If the sheet is *undamaged*, then the sheet can have fasteners placed mid-way between the existing fasteners. If the lining is only refastened to the edge studs, then only a small improvement in element stiffness is achieved. If the lining is refastened around the entire perimeter of the element, then the element stiffness is approximately 80% of the original element stiffness.** If, however, an **overlay** is used, then the element stiffness is similar to the original element stiffness and the element strength is increased. Longer fasteners (eg 41 mm instead of 32 mm fasteners) should be used when installing an overlay. These fasteners should be slightly offset from the existing fasteners.

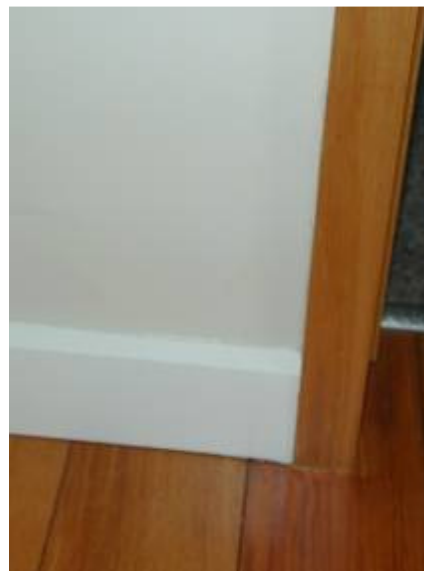
(b) Hardly Visible Fastener Movement

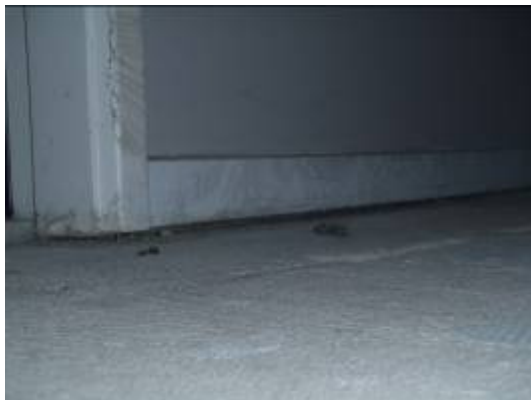
Damage of the connection of bottom plate to floor system can be the most difficult type of damage to identify as the movement as a result of this damage is often hidden behind skirtings or carpet. Damage can be a result of the bottom plate lifting away from the floor. In a GS type element this is a consequence of the fasteners pulling out of the floor system. This movement has been observed in a number of cases of GS type elements on concrete floors. When this type of movement has been identified, either after an earthquake or during testing, there is commonly little or no damage to plasterboard or framing.

(a) Element Uplift After Earthquake

- (i) Damage to hold-down system attaching the bracing element to the flooring. Careful inspection of the bottom of the element needs to be undertaken and if the hold-system is considered to be compromised, then linings should be removed and new hold-downs installed. If an overlay system is going to be used then the holes can be cut in the old lining and patched before fixing the overlay in order to facilitate the installation of new hold-downs.

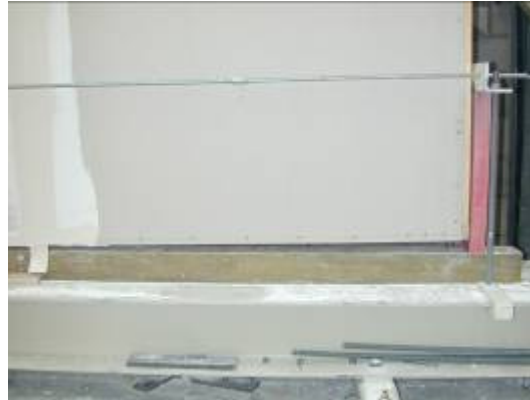
(b) Element Uplift During Testing

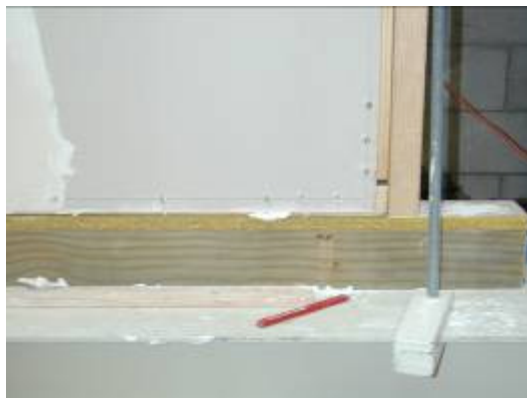
Plate 7

In some cases the studs have pulled away from the bottom plates. This results in damage to the plasterboard around the fasteners attaching the lining to the bottom plate. This damage is often hidden behind skirting.

Damage to Linings as a Result of Studs Separating from Bottom Plate

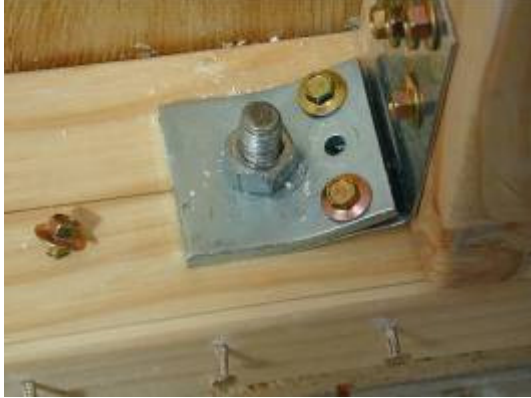
In plasterboard bracing elements with hold-downs, there can be considerable damage to the hold-down as a consequence of earthquake movement. The damage can cause the studs to move relative to the bottom plate resulting in considerable movement of the fasteners attaching the lining to the bottom plate.

(a) Damage to Hold-Down

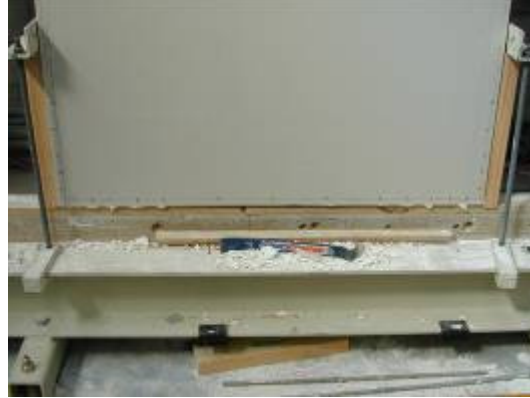
(b) Damage to Bottom of Sheet

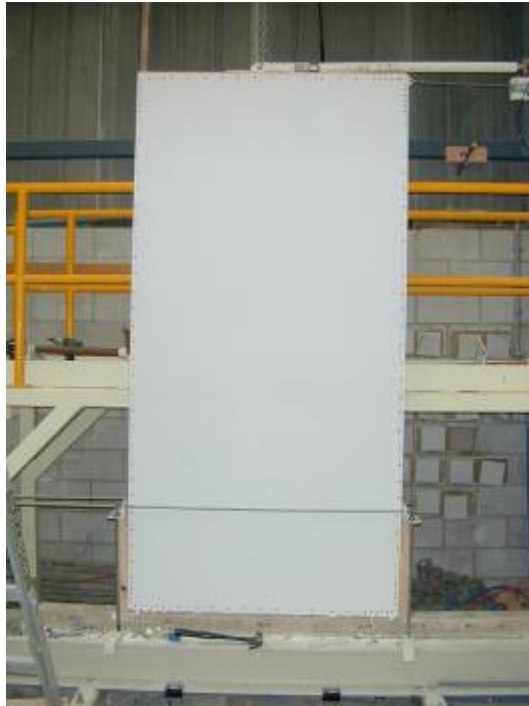
During early the stages of testing of the elements, significant damage was observed around the fasteners attaching the lining to framing. Initially this damage was concentrated towards the bottom of the element but then spread to the fasteners on the top plate. This early damage around the fasteners could possibly explain why the full strength and stiffness of the element, as shown in Figure 8 and 9, was not achieved after refastening of the lining.

Plate 9
Refastened Bracing Element after Testing

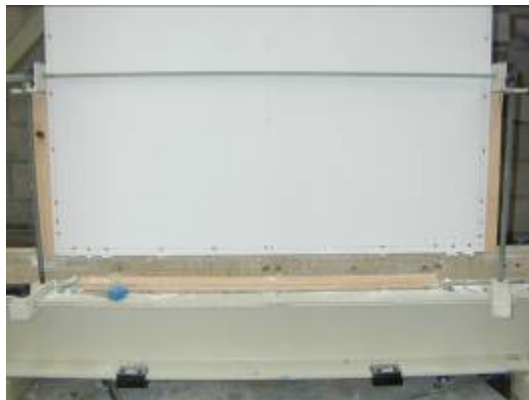
Plate 11

Little damage to the overlaid sheets was observed after testing. The only damage was concentrated towards the bottom of the elements.

Typical Damage to the Bottom of Overlaid Bracing Element
