REINFORCING TAPE FOR GIB® PLASTERBOARD JOINTS – PREVENTING FAILURES

CASE STUDY 5

by Zoe Xie
Development Chemist

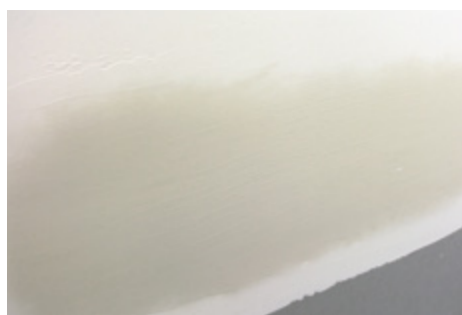
FIGURE 1: Basecoat compound has a darker colour and indicates it has set properly.

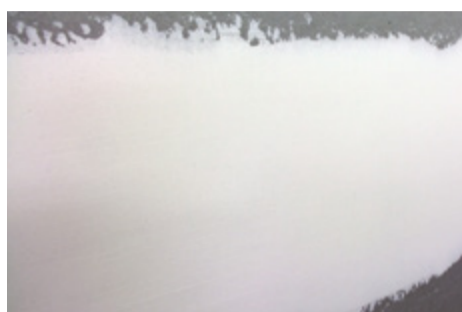
FIGURE 2: Basecoat compound is lighter in colour and shows it has not set properly.

Dried before setting.

One common failure is when the chemical bonding process is not fully accomplished due to water loss in the compound and insufficient water present when setting needs to occur. This phenomena is where the compound has dried out before it sets and there is no, or insufficient, water left in the compound after the working time has finished. The plaster then doesn't have water for the chemical reaction to occur and form gypsum crystals. The drying out before setting phenomena is more common during hot weather conditions and when using compounds with longer working time. Figures 1 and 2 show the colour differences between a standard hydrated setting compound. The dark basecoat plaster hydrated to form gypsum crystals. Compared with the much lighter in colour, dry basecoat compound that has not set and is still plaster that hasn't changed to gypsum.

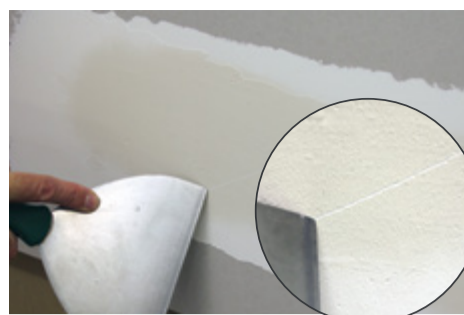
When the plaster hasn't set it is still soft. Scraping the light coloured joint (with the plaster that hasn't set) a deep gouge is made. As opposed to scraping the darker coloured joint (where the plaster has set and changed to gypsum) only a shallow scratch is made (see figures 3 and 4). Also when the plaster hasn't set the bonding strength isn't there to hold in the tape and causes the bedding coat to fail.

FIGURE 3: A scratch in a properly set basecoat is only super-visual and indicates it is hard.

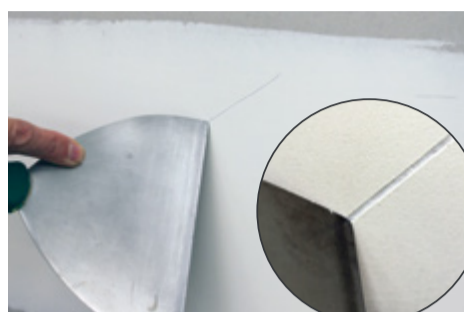
FIGURE 4: A scratch in a basecoat not properly set goes deep/right through and indicates it is soft.

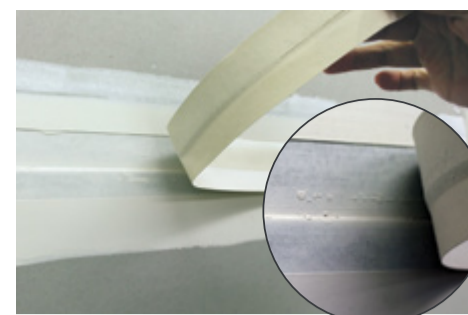
The other common failure seen with paper joint tapes is where the joint has bubbled, cracked or is falling out. These symptoms are often due to the lack of mechanical entanglement with the surface of the plasterboard or paper joint tape and are referred to as tape adhesion failure. Good tape adhesion requires an adequate amount of compound placed behind/under the paper joint tape. At least 0.5mm thickness of compound is required under paper joint tape.

Figures 5 and 6 show the performance of a standard paper tape joint and compared to a failed embedded paper joint tape that had inadequate contact between the plaster, the surface of plasterboard or paper joint tape. The joint will not achieve adequate reinforcing if inadequate compound has been placed underneath the paper joint tape.

FIGURE 5: Inadequate compound under the tape and the tape can be removed relatively clean and easily.

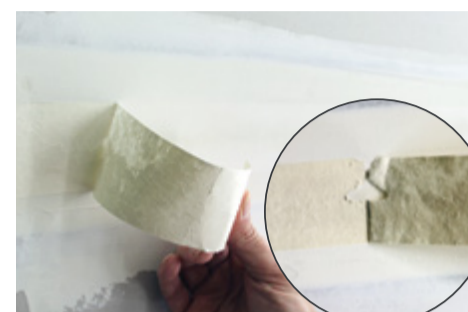
FIGURE 6: Here the tape has adhered well. It is difficult to pull out and delaminates when pulled out.

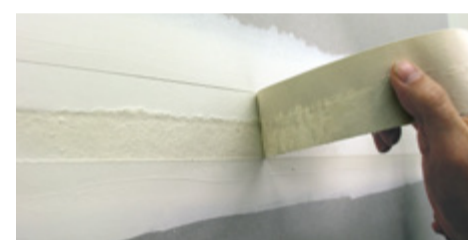
Figure 7 shows where the two plasterboards sheets that form a joint are not flat (ie, one is higher than the other). Half the paper joint tape has adhered well (ie, the lower half where the paper is delaminating when pulled out), and half the paper tape hasn't adhered well and comes out relatively cleanly. Under the top half of the paper tape there is little compound, it is so thinly applied that the plasterboard paper can be seen.

FIGURE 7: Shows lower half of the tape has adhered well to the basecoat and the top half has not, indication inadequate compound under the top half.
