# Health & Safety

## The Canterbury Earthquake

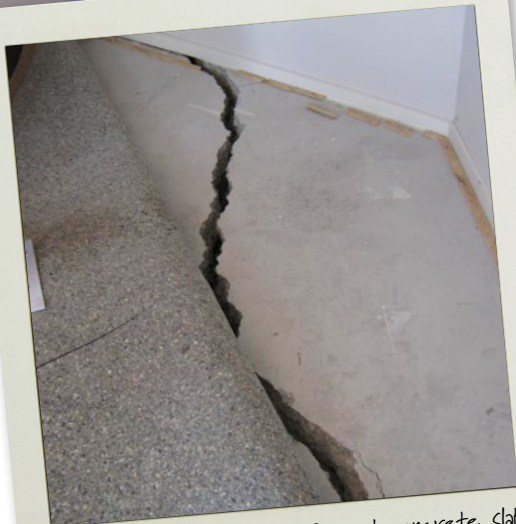
It is on these soft soils that structural damage has been greatest, particularly to brick veneer homes on un-reinforced concrete slabs. Subsidence and lateral spread (ground cracks opening up) caused slabs to slump and break, and the rest of the structure to follow. Engineers are working with builders, house removal companies and insurers to establish technical feasibility of reinstatement. The repair of many such structures will be expensive if possible at all.

Broken residential un-reinforced concrete slab and consequential damage to internal linings due to lateral spread

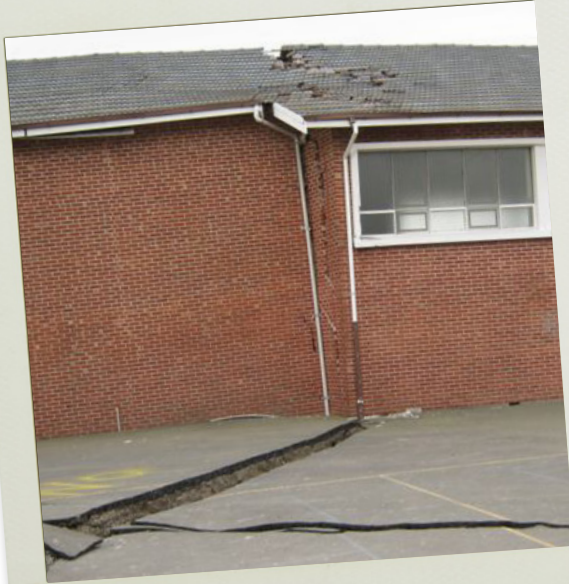
School hall broken in half  
due to subsidence
