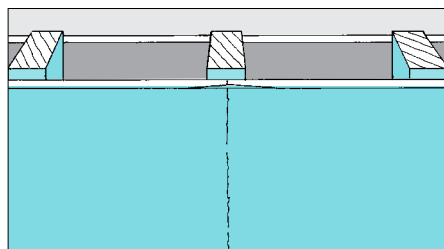
CENTRE CRACKING

Cracks appear in the joint down the centre of the joint tape.

Cause Abnormal stress build-up resulting from structural deflection or racking.

Excessive stresses resulting from hygrometric and/or thermal expansion and contraction.

Remedy Relieve stress, provide adequate isolation by installing a control joint and re-tape. Feather compound over broad area to disguise build-up.

1. Correct unsatisfactory environmental conditions. Provide sufficient relief and re-tape
2. Provide proper isolation from structure to prevent stress build-up.
3. Provide adequate control joints.
4. Structurally brace underlying framing.
5. Ensure moisture content of timber is 18% or less.

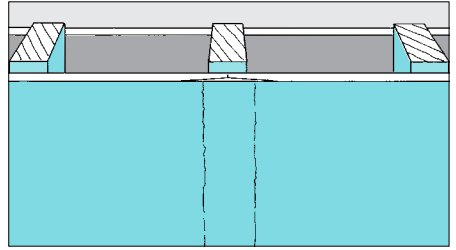
EDGE CRACKING

Cracks at edge of paper tape or GIB® Goldline™ trims.

1. Fast drying of taping compound because of high temperature and low humidity or excessive drafts.
2. Improper application, such as over-dilution of compound, use of wrong compound, excessive compound under tape, no second coat over tape.
3. Cold, wet application conditions (also causes poor bond).

Remove all poorly bonded tape and reapply compound and tape in correct manner.

In hot, dry conditions, use GIB Plus 4® or GIB ProMix® All Purpose which dries slower than conventional setting compounds i.e. provides more open time. Place shielding devices over room openings to prevent drafts. Do not apply joint treatment over hot surfaces. Lightly wet down floors if room humidity is too low. During cold weather, control heat at min. 10°C and supply good ventilation. Avoid practices listed under “Cause” above.

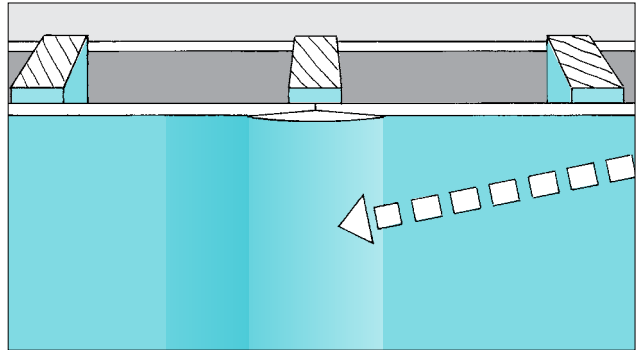
HIGH CROWNS

Joint area is higher than the surrounding plasterboard and may result in shadowing across the joints.

1. Excessive compound over joint.
2. Compound not feathered out beyond shoulders.
3. Improper bedding of tape.
4. Framing out of alignment or sheet edges not tight against framing.
5. Improper adjustment of mechanical tools.
6. Misuse of or worn tools.

Sand joints to flush surface (take care to avoid scuffing paper or joint tape by over-sanding).

Embed tape properly, using only enough compound to cover tape. Fill tape depression or tape itself at butt joints. Adequately feather compound.

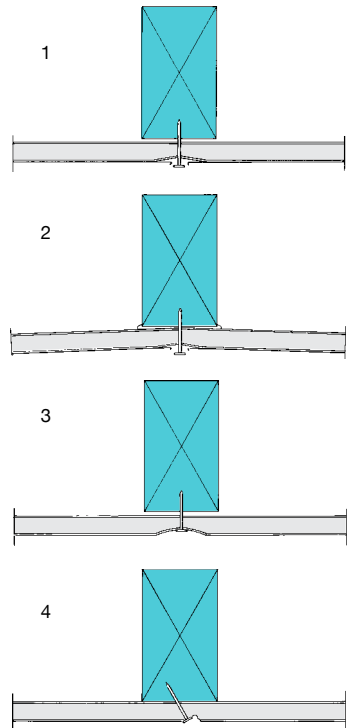
NAIL/SCREW POPS

1. Protrusions or bumps directly over the nail/screw head.
2. Rupture of the surface around nail/screw head.
3. Looks like nail/screw head protruding above the surface of the board.
4. Blister in the board (convex or concave).

1. Timber Shrinkage - Timber shrinks as it dries causing the fastener to protrude. Nail/screw pops may not become apparent for some considerable time after installation.
2. Fixing through glue - If screws or nails are applied through adhesive a pop can occur as the glue dries and shrinks back pulling the plasterboard closer to the framing member.
3. Plasterboard not held in close contact with the framing members - If the plasterboard is not held firmly against the stud while fixing it increases the possibility of over-driving the nail, resulting in a blister like defect the size of the hammerhead.
4. Overdriven or skewed nails/screws can puncture the face paper, which results in no holding power.

Nail pops that occur after at least one months heating cycle are probably caused by timber shrinkage. Because further shrinkage is likely to occur and pops reappear, do not repair until the end of a heating season.

A screw should be reapplied 50mm from the popped fastener. Drive in a new fastener whilst applying firm pressure to ensure firm contact with framing. Use a nail punch to seat the popped fastener beneath the surface of the plasterboard. Remove loose compound and paper. Apply two coats of taping compound followed by a topping coat then redecorate.

5. Timber shrinkage - Use GIB® Rondo® Metal Ceiling Battens for ceilings or kiln dried timber. Close in the building and protect the framing from the elements as soon as possible. Ensure that timber moisture content is 18% or less at the time of lining. Use of steel battens for large ceiling areas will eliminate shrinkage factors.
6. Fixing through glue - For walls; use nails/screws around the perimeter and GIBFix® adhesive in the centre. No mechanical fastener should be within 200mm of an adhesive daub. Never nail/screw through glue.
7. Plasterboard not in close contact with the framing members - When fixing ceilings fix the centre of the plasterboard first. In all cases hold the plasterboard firm against the framing member whilst fixing.
8. Nailheads/screwheads puncturing face paper - Drive nails/screw in straight so they are neatly seated slightly below the surface of the sheet.

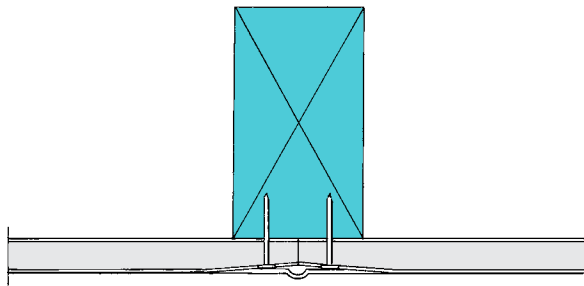
PEAKING

A condition where joints are visible under critical lighting. More prevalent when board has been installed in cold weather. Often called ridging or beading. Looks like a continuous ridge along the length of the joint, with a uniform peak like pattern at the centre. Commonly occurs in conjunction with 'nail popping'.

1. Excessive gaps (i.e. over 3mm) left between sheets.
2. Timber movement due to excessive moisture content of timber at time of lining and subsequently drying out. This is more prevalent with 10mm plasterboard than thicker plasterboards.
3. No gaps at the base of wall sheets. This can cause pressure on the base of the sheets thus transferring tension to the joints.
4. Inadequate ventilation with concrete floor slabs. Results in a build up of water vapour.

Ridges must only be repaired after a full heating cycle: (6 months to a year). February is generally the best month for rectifications.

Apply a coat of setting compound over the joints using a 300mm trowel to widen the joint. Scrape back and apply a light coat of a topping coat. Re-seal affected area. Examine the surface with harsh lighting to determine whether the ridge has been concealed. If all right, then decorate.

1. Use GIB® Rondo® Metal Ceiling Battens on ceilings.
2. Ensure timber framing moisture content is 18% or less at time of lining.
3. Use compounds at the heaviest consistency as possible.
4. Use a back blocking system.
5. Gaps between sheets should be pre-filled with a setting compound and allowed to completely dry before application of tape and subsequent coats of compound.
6. Always allow a 5-10mm gap at the base of wall sheets to allow for shrinkage of the wall plates and studs.
7. Use thicker plasterboards such as 13mm.
8. Ensure framing materials are maintained at a minimum temperature of 10°C during and following installation. Allow adequate ventilation.

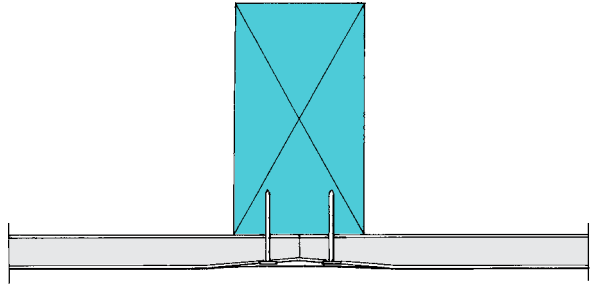
SHRINKAGE

Compound shrinking back when it dries causing a depression at the joint or on a fastener. Looks like depressions at the joint.

1. Compound too thin or watery.
2. Inadequate drying between coats.
3. Slow drying due to excessive filling in one coat.
4. Re-tempering setting compounds which break up the gypsum crystal structure and causing shrinkage.
5. Under slow drying conditions, joints and plasterboard may hold moisture for weeks.

Lightly sand affected areas and re-apply jointing and topping compounds and sand using 220 grit or finer sand paper. Re-seal affected area and then fully decorate.

Provide proper drying conditions for compound. The two setting coats must be thoroughly dry prior to top coating. The top coat must be thoroughly dry prior to application of sealer.

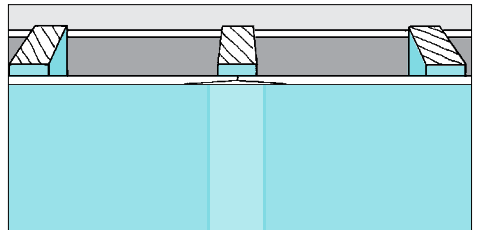
TRAM LINES/TRACKS

Shrinkage of the paper tape within the joint compound. Looks like the tape is visible on the joint.

1. The first coat of compound is not sufficiently dry before the second coat is applied. When the first coat dries it shrinks and pulls the tape back into the joint.
2. Compound is too thin or watery.
3. Inadequate drying between coats. Poor drying conditions.
4. Slow drying due to excessive filling in one coat.
5. Premature paint application.

Lightly sand affected areas.

Apply a skim coat to the joint with a setting joint compound, then a top coat and sand. Decorate.

Allow joint compound to fully dry between coats.

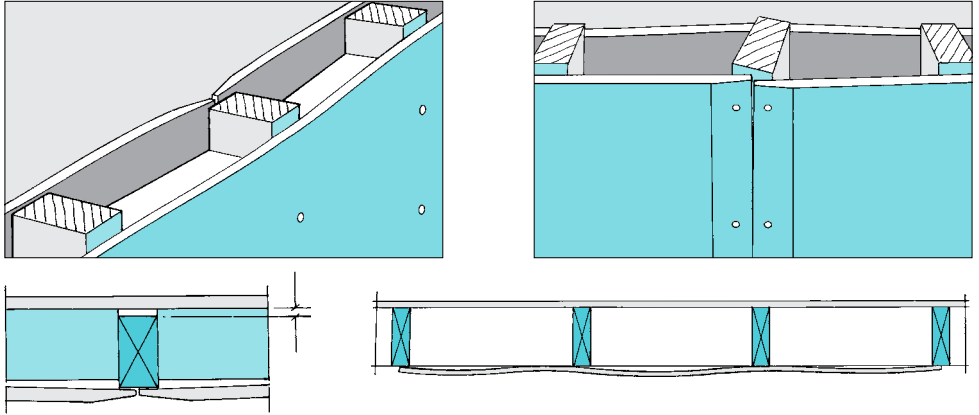
WAVY SURFACES

Plasterboards are not flat but have a bowed, dished or undulating surface. Studs or ceiling joists not on the same plane as other framing members. A twisted framing member. Shadows being cast across the joint. Plasterboard forced into place.

1. Framing oversights. Framing out of alignment with adjacent framing making it difficult to bring the sheet into firm contact with framing members.
2. Excessive moisture in the timber framing can also cause warpage, twisting or bowing as it dries.

3. Fixing the perimeter of the sheet prior to the centre.
4. Fixing of damp plasterboard.
5. Excessive loading from insulation or light fittings causing too much weight on plasterboard.

6. Incorrect placement of vapour barrier causing moisture build up within the plasterboard.
7. Exceeding maximum span of fasteners when fixing.
8. Not allowing a 5-10mm gap between the floor and the plasterboard.

9. Incorrect fastening sequence for lining light gauge steel framing.
10. High temperatures in the ceiling space causing board expansion, particularly in skillion roofs with poor ventilation.

11. Incorrect storage- storing of plasterboard on edge on damp concrete floors.

It is extremely difficult to rectify some of these problems without having to resort to full replacement of the linings after rectifying underlying factors.

Replace all warped or crooked studs.

1. Timber members must be brought into alignment.
2. Check stud, batten and joist alignment, correcting wherever necessary.
3. Always fix from the centre outwards
4. Sheets must be touch fitted and not forced into place.
