GIB[®] Screw Hollows –

Why they occur and what care to take.

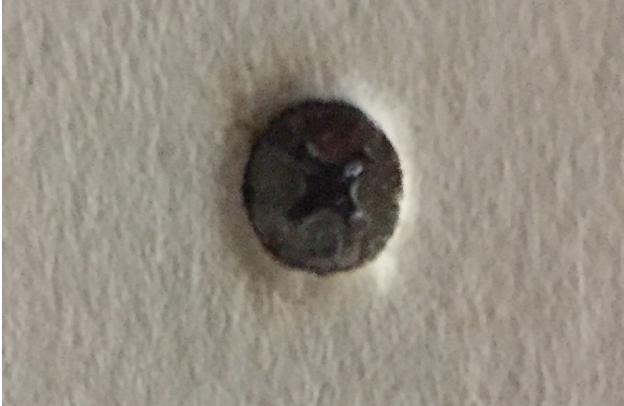
Moisture movement occurs around screw heads, more so on over driven screws. The moisture can come from compounds and paints. Adding water to these compounds and thinning paints can increase the likelihood of problems. Delayed shrinkage may also occur if each coat is not completely dried before the next coat.

Most of the cases of screw hollows occurred on ceilings, only occasionally on the walls. The ceilings we believe exhibit these more so due to the pull of gravity coupled with the weight of insulation.

To avoid call backs each part of the job needs to be done well.
