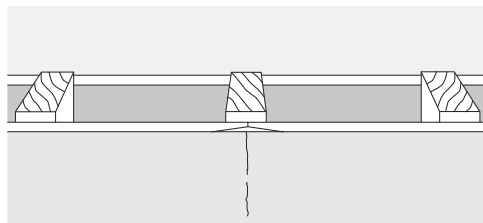
Centre Cracking

- Cracks appear in the joint down the centre of the joint tape

- Abnormal stress build-up resulting from structural deflection or racking
- Excessive stresses resulting from hygrometric and/or thermal expansion and contraction

Relieve stress, i.e. providing adequate isolation by installing a control joint and re-taping, then feathering compound over broad area to disguise build-up

- Correct unsatisfactory environmental conditions
- Provide sufficient relief and re-tape
- Provide proper isolation from structure to prevent stress build-up
- Provide adequate control joints
- Structurally brace underlying framing
- Ensure moisture content of timber is 18% or less

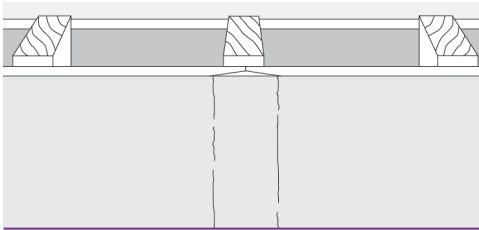
Edge Cracking

- Cracks at edge of GIB® tape or GIB® Goldline® trims

- Fast drying of taping compound due to high temperature and low humidity, or excessive drafts
- Improper application, e.g. over-dilution of compound, use of wrong compound, or no second coat over tape
- Cold, wet application conditions (also causes poor bond)

- Remove all poorly bonded tape, then reapply compound and tape in correct manner

- In hot, dry conditions, use GIB Tradeset® 45
- In extreme conditions use a multi-purpose air drying compound. **Note:** these dry rather than set, so provide more open time
- Place shielding devices over room openings to prevent drafts. Do not apply joint treatment over hot surfaces
- During cold weather, control heat at minimum 10°C and supply good ventilation
- Avoid practices listed under “Cause” opposite

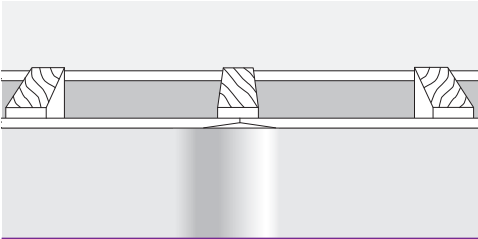
High Crowns

- Joint area is higher than the surrounding plasterboard and may result in shadowing across the joints

- Excessive compound over joint
- Compound not feathered out beyond shoulders
- Improper bedding of tape
- Framing out of alignment or sheet edges not tight against framing
- Improper adjustment of mechanical tools
- Misuse of, or worn, tools

- Sand joints to flush surface (take care to avoid scuffing paper or joint tape by over-sanding)

- Embed tape properly, using only enough compound to cover tape. Adequately feather compound

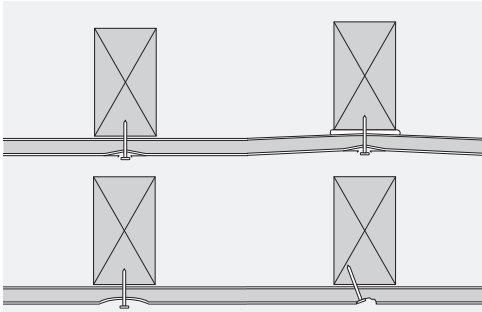
Nail/Screw Pops

- Protrusions or bumps directly over the nail/screw head
- Rupture of the surface around nail/screw head
- Looks like nail/screw head protruding above the surface of the board

- Timber shrinkage (timber shrinks as it dries, causing the fastener to protrude). Nail/screw pops may not become apparent for some considerable time after installation
- Fixing through glue – if screws or nails are applied through adhesive, a pop can occur as the glue dries and shrinks back; pulling the plasterboard closer to the framing member
- Plasterboard not held in close contact with the framing members. If the plasterboard is not held firmly against the stud while fixing, it increases the possibility of over-driving the nail (resulting in a blister-like defect the size of the hammerhead)
- Overdriven or skewed nails/screws can puncture the face paper, which results in no holding power
- Air trapped between the fixture and the compound, when the compound is placed
- Nail heads/screw heads puncturing face paper

- Nail pops that occur after at least one month's heating cycle are probably caused by timber shrinkage. Because further shrinkage is likely to occur and pops reappear, do not repair until the end of a heating season
- A screw should be reapplied 50mm from the popped fastener. Drive in a new fastener whilst applying firm pressure, to ensure firm contact with framing. Use a nail punch to seat the popped fastener beneath the surface of the plasterboard
- Remove compound. Apply two coats of setting compound followed by an air dry compound coat, then redecorate

- Avoid timber shrinkage by using GIB® Rondo® metal ceiling battens for ceilings or kiln dried timber. Close in the building and protect the framing from the elements as soon as possible. Ensure that timber moisture content is 18% or less at the time of lining. Use of steel battens for large ceiling areas will eliminate shrinkage factors

- Fixing through glue – for walls, use nails/screws around the perimeter and GIBFix One® or GIBFix® All-Bond adhesive in the centre of the sheet. No mechanical fastener should be within 200mm of an adhesive daub. Never nail/screw through glue

- Plasterboard not in close contact with the framing members – when fixing ceilings, fix the centre of the plasterboard first. In all cases hold the plasterboard firm against the framing member whilst fixing

- Drive nails/screw in straight so they are neatly seated slightly below the surface of the sheet
- Apply compound in critical light areas by pressing the compound into the fixings, rather than trowelling it on. This removes trapped air

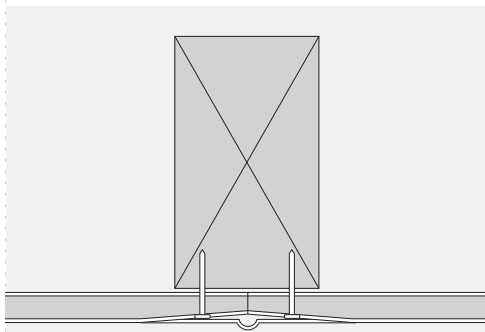
Peaking

- A condition where joints are visible under critical lighting
- More prevalent when board has been installed in cold weather
- Often called ridging or beading
- Looks like a continuous ridge along the length of the joint, with a uniform peak-like pattern at the centre
- Commonly occurs in conjunction with 'nail popping'

- Excessive gaps (i.e. over 2mm) left between sheets
- Timber movement due to excessive moisture content of timber at time of lining and subsequently drying out. This is more prevalent with 10mm plasterboard than thicker plasterboards
- No gaps at the base of wall sheets. This can cause pressure on the base of the sheets thus transferring tension to the joints
- Inadequate ventilation with concrete floor slabs, resulting in a build-up of water vapour

- Ridges must only be repaired after a full heating cycle (6 months to a year). Mid-summer is generally the best time for rectifications
- Apply a coat of setting compound over the joints using a 300mm trowel to widen the joint. Scrape back and apply a light coat of a topping coat. Reseal affected area. Examine the surface with harsh lighting to determine whether the ridge has been concealed. If all right, then decorate

- Use GIB® Rondo® metal ceiling battens on ceilings
- Ensure timber framing moisture content is 18% or less at time of lining
- Use a back blocking system on ceilings
- Gaps between sheets should be pre-filled with a setting compound and allowed to completely dry before application of tape and subsequent coats of compound
- Always allow a 5mm-10mm gap at the base of wall sheets to allow for shrinkage of the wall plates and studs
- Ensure compound materials are maintained at a minimum temperature of 10°C during, and following, installation. Allow adequate ventilation

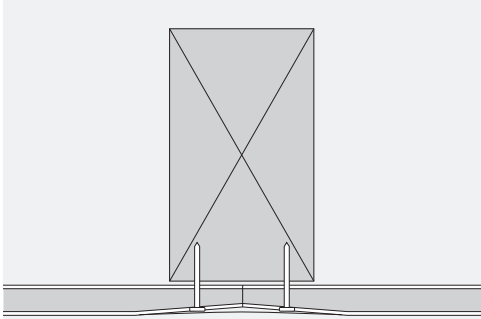
Shrinkage

- Compound shrinking back when it dries, causing a depression at the joint or on a fastener
- Looks like depressions at the joint

- Compound too thin or watery
- Inadequate drying between coats
- Slow drying due to excessive filling in one coat
- Under slow drying conditions, joints and plasterboard may hold moisture for weeks

- Lightly sand affected areas and apply air drying compound, then sand (using 220 grit or finer sand paper)
- Seal repaired areas and then re-decorate

- Provide proper drying conditions for compound. The two setting coats must be thoroughly dry prior to top coating. The top coat must be thoroughly dry prior to application of sealer
- Use compound at heaviest workable consistency and allow to stand for 2–3 minutes before applying
- In slow drying conditions apply a number of thinner coats rather than a few thick coats
- Under slow drying conditions use shorter set time joint compounds
- Allow joint compound to fully dry between coats

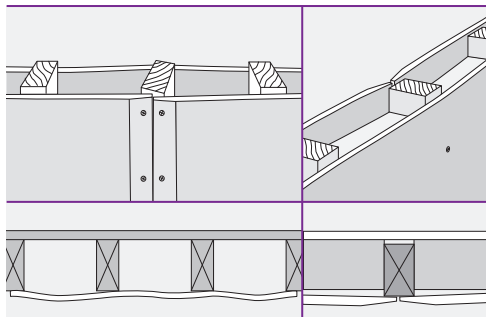
- Plasterboards are not flat but have a bowed, dished or undulating surface
- Studs or ceiling joists not on the same plane as other framing members
- A twisted framing member
- Shadows being cast across the joint
- Plasterboard forced into place

- Framing oversights
- Framing out of alignment with adjacent framing, making it difficult to bring the sheet into firm contact with framing members
- Excessive moisture in the timber framing can also cause warping, twisting or bowing as it dries
- Fixing the perimeter of the sheet prior to the centre
- Fixing of damp plasterboard
- Excessive loading from insulation or light fittings causing too much weight on plasterboard
- Incorrect placement of vapour barrier causing moisture build-up within the plasterboard
- Exceeding maximum span of fasteners when fixing
- Not allowing a 5mm–10mm gap between the floor and the plasterboard
- Incorrect fastening sequence for lining light gauge steel framing
- High temperatures in the ceiling space causing board expansion, particularly in skillion roofs with poor ventilation
- Incorrect storage – storing of plasterboard on edge on damp concrete floors

- It is extremely difficult to rectify some of these problems without having to resort to full replacement of the linings after rectifying underlying factors
- Replace all warped or crooked studs

- Timber members must be brought into alignment
- Check stud, batten and joist alignment, correcting wherever necessary
- Always fix from the centre outwards
- Sheets must be touch fitted and not forced into place
