Best Practice Guidelines to minimise fasteners popping

GIB® Information Bulletin
Issue Date: November 2014

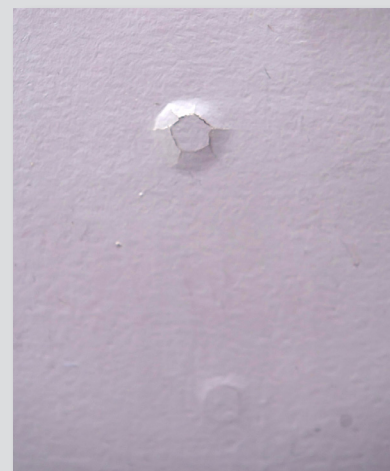
'**Popping**' describes the protrusion of fastener heads through the finished surface of plasterboard. Popping may not become visible for some considerable period after completion. They may be just sitting there hidden under the paint until something like a door is slammed or the house moves slightly.

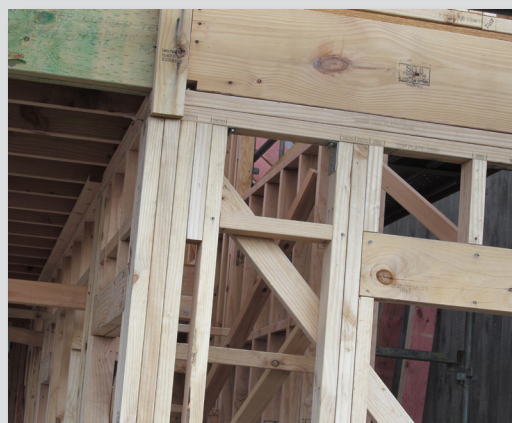
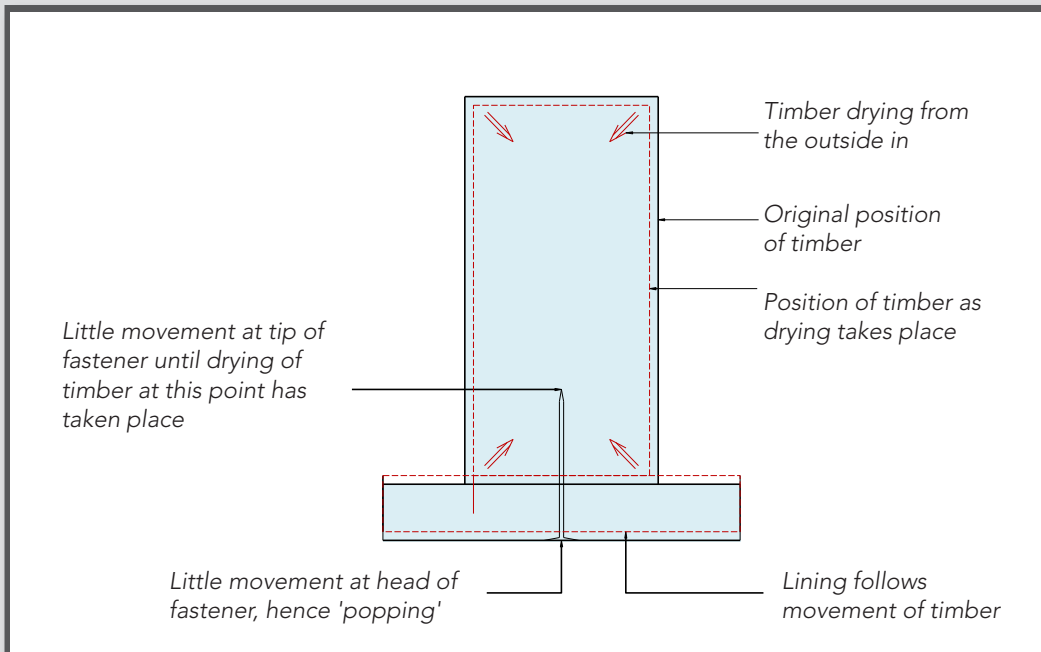
1. SUBSTRATE MOVEMENT: Popping can be attributed to movement in the substrate. Timber substrates are more prone to temperature or moisture induced movement and shrinkage.

Timber dries from the outside in. Therefore shrinkage occurs from the outside in. Refer to diagram overleaf.

A screw or nail that penetrates to a reasonable depth within the timber will span the area on the outside that is shrinking, and also the area further in that has not shrunk yet. Because of this the screw or nail does not move. However, the board glued to the outside of the timber that is shrinking does move inwards, causing pops. An example of this is timber decking that shrinks as it dries (mainly in summer) leaving the nails proud.

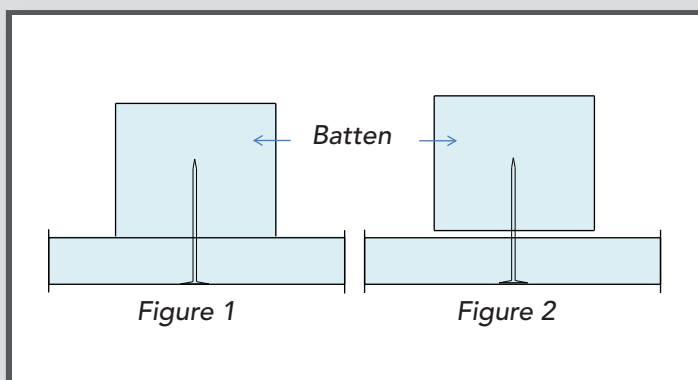
ENSURE LININGS ARE FLUSH WITH FRAMING: Whenever the back of the plasterboard is not held tight and secure against the face of the framing substrate by the head of the fastener, a potential fastener pop exists.

Figure 1: Nails are less likely to pop when plasterboard is nailed tight against framing substrate.

Figure 2: Any inward pressure on the panel will push the nail head through the thin covering of joint compound.
