Reinforcing tape for GIB® plasterboard joints — preventing failures

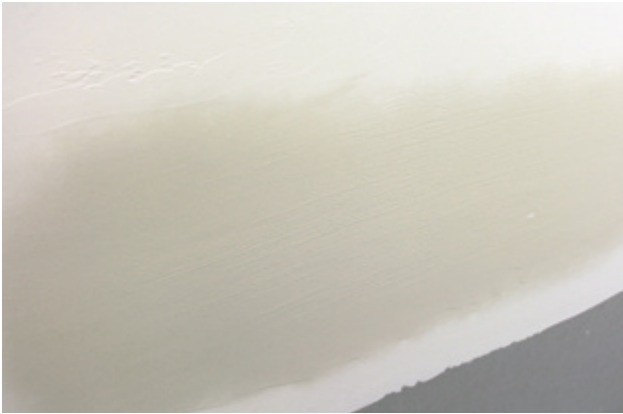
FIGURE 1: Basecoat compound has a darker colour and indicates it has set properly.

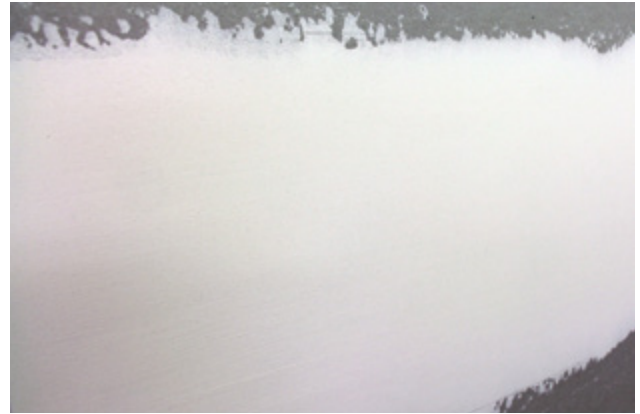
One common failure is when the chemical bonding process is not fully accomplished due to water loss in the compound and insufficient water present when setting needs to occur. This phenomena is where the compound has dried out before it sets and there is no, or insufficient, water left in the compound after the working time has finished. The plaster then doesn't have water for the chemical reaction to occur and form gypsum crystals. The drying out before setting phenomena is more common during hot weather conditions and when using compounds with longer working time. Figures 1 and 2 show the colour differences between a standard hydrated setting compound. The dark basecoat plaster hydrated to form gypsum crystals. Compared with the much lighter in colour, dry basecoat compound that has not set and is still plaster that hasn't changed to gypsum.

When the plaster hasn't set it is still soft. Scrapping the light coloured joint (with the plaster that hasn't set) a deep gouge is made. As opposed to scrapping the darker coloured joint (where the plaster has set and

FIGURE 2: Basecoat compound is lighter in colour and shows it has not set properly.

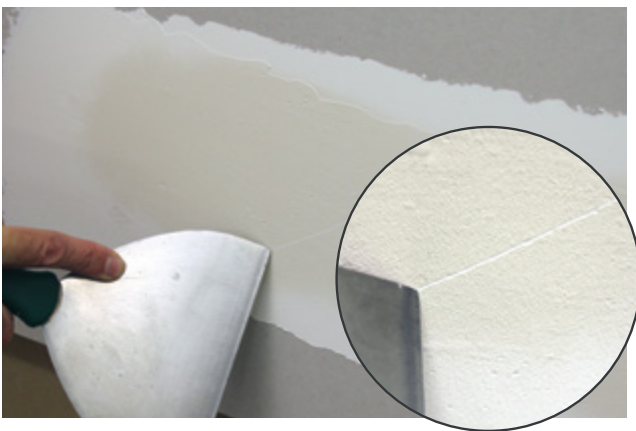
changed to gypsum) only a shallow scratch is made (see figures 3 and 4). Also when the plaster hasn't set the bonding strength isn't there to hold in the tape and causes the bedding coat to fail.

FIGURE 3: A scratch in a properly set basecoat is only supervisual and indicates is it a hard.

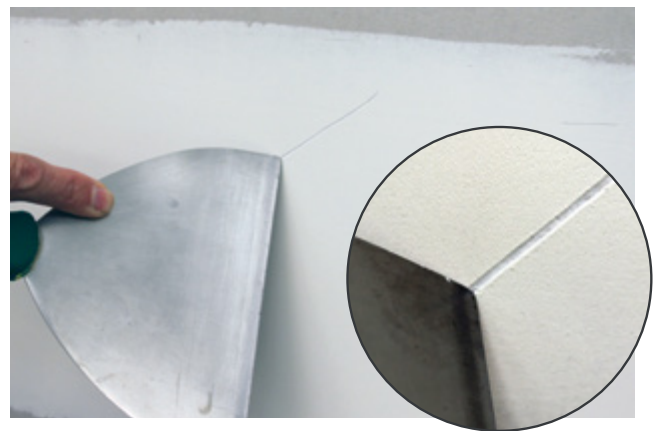
FIGURE 4: A scratch in a basecoat not properly set goes deep/right through and indicates is it soft.

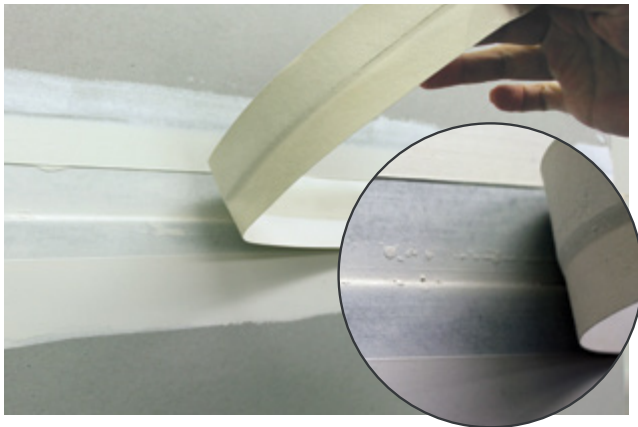
The other common failure seen with paper joint tapes is where the joint has bubbled, cracked or is falling out. These symptoms are often due to the lack of mechanical entanglement with the surface of the plasterboard or paper joint tape and are referred to as tape adhesion failure. Good tape adhesion requires an adequate amount of compound placed behind/under the paper

Figures 5 and 6 show the performance of a standard paper tape joint and compared to a failed embedded paper joint tape that had inadequate contact between the plaster, the surface of plasterboard or paper joint tape. The joint will not achieve adequate reinforcing if inadequate compound has been placed underneath the paper joint tape.

FIGURE 5: Inadequate compound under the tape and the tape can be removed relatively clean and easily.

joint tape. At least 0.5mm thickness of compound is required under paper joint tape.

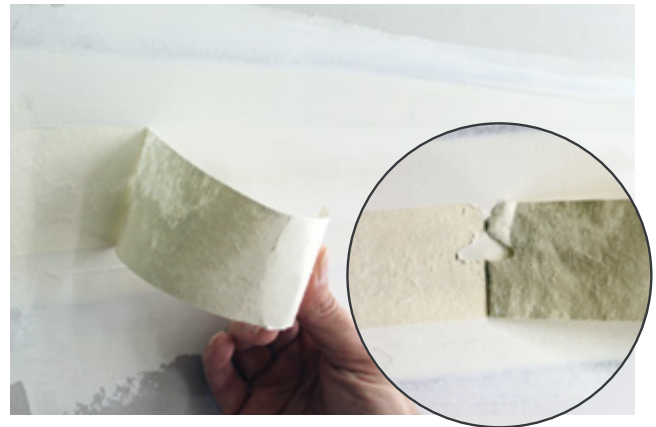
FIGURE 6: Here the tape has adhered well. It is difficult to pull out and delaminates when pulled out.

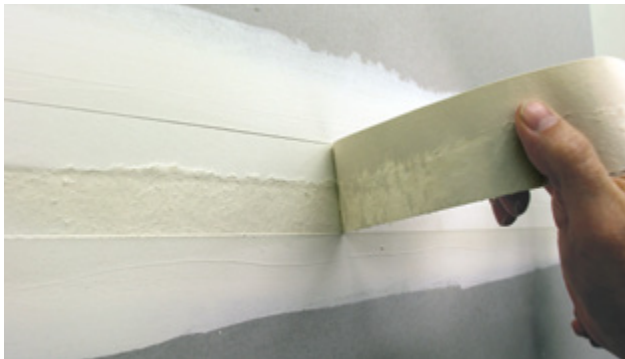
FIGURE 7: Shows lower half of the tape has adhered well to the basecoat and the top half has not, indication inadequate compound under the top half.

Figure 7 shows where the two plasterboards sheets that form a joint are not flat (ie, one is higher than the other). Half the paper joint tape has adhered well (ie, the lower half where the paper is delaminating when pulled out),

and half the paper tape hasn't adhered well and comes out relatively cleanly. Under the top half of the paper tape there is little compound, it is so thinly applied that the plasterboard paper can be seen.
