The February Christchurch Earthquake

Bracing Systems prove effective in earthquake

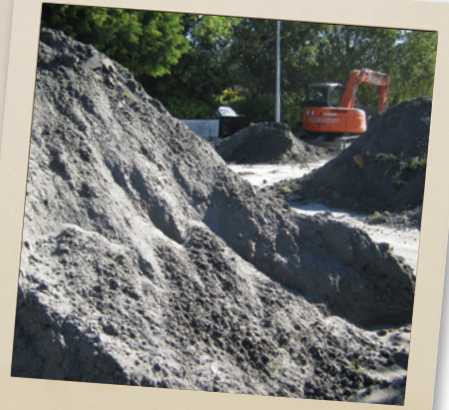
Damage on soft soils included cracked, broken or tilted concrete slab, cracked or fallen chimneys and brick veneers, shifted pile foundations and internal lining cracks as a result of settlement, typically at sheet joints around window and door openings. Not surprisingly, concrete slab houses with brick veneer and heavy tile roofs suffered most on soft soils. Although damage on rock and hillsides was similar, it could be directly attributed to shaking.

Piles of silt in some streets collected following liquefaction

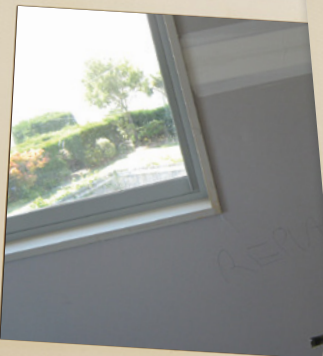
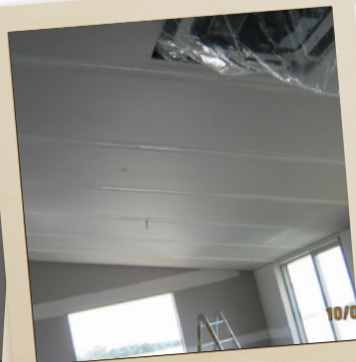
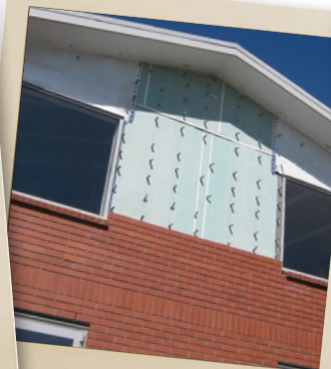
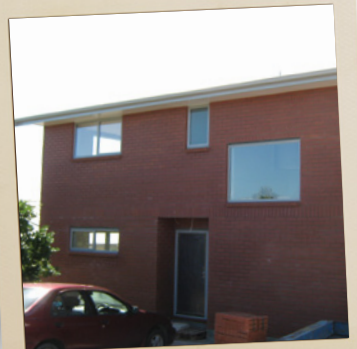
Houses under construction also provided important information. We found such a two storey brick veneer house in the severely affected suburb of Mt Pleasant, carefully designed by the building inspector/owner with designated horizontally fixed GSI and GS2 bracing elements clearly marked on the floor and installed using the specified fastener pattern. The plasterers were at work when the earthquake hit, and stopped sheet joints were still fresh. Apart from expected shear failures of the wet plaster joints, the house, supported by GIB® bracing systems, stood up very well.

Building inspector's Mt Pleasant home under construction lost some of its brick veneer, but performed well supported by GIB® bracing systems
