GUIDELINES FOR REPAIRING GIB® PLASTERBOARD LININGS IN WIND OR EARTHQUAKE DAMAGED PROPERTIES

Supplement to: GIB® Site Guide, January 2010; GIB® Fire Rated Systems, January 2006; and GIB EzyBrace® Systems 2011

SCOPE OF USE

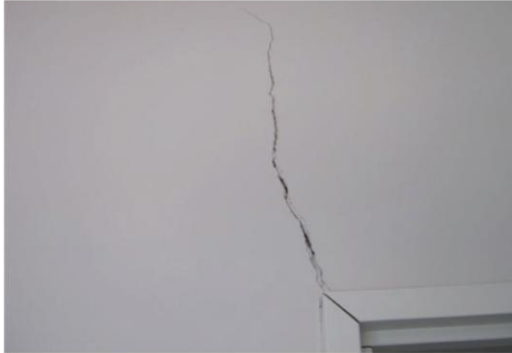
Significant sheet fracture

Sheet breakage differs from a joint crack in that the plasterboard sheet itself has actually fractured. Often this will have occurred where a sheet has been cut at the corner of a door or window opening or at a change of direction in a ceiling. Sheet fractures can sometimes occur between framing members and are obvious when the sheet is pushed. Smaller breakages less than 300 mm long in non-structural applications can be ground out with an angle grinder and jointed using GIB[®] paper tape embedded in a setting compound such as GIB Tradset[®] 20 or 45 and then finished with a light coat of GIB Plus 4[®], GIB Trade Finish[®] or GIB Promix[®] Lite.

³ Any sheet fracture repair will not be as strong as the original sheet material and damage is likely to repeat following any future movement as a result of wind, earthquake, impact or even traffic vibrations. If in doubt, replace.

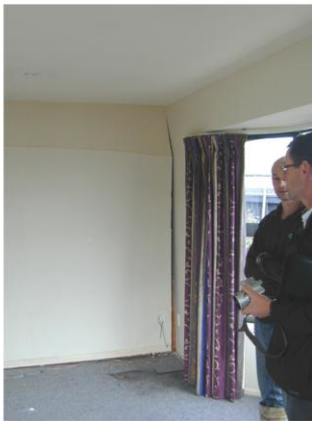
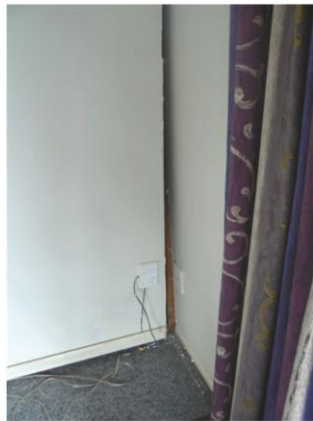
Lining detached from the framing requiring replacement of the bracing element.

Any damaged sections of wall forming part of a bracing element must be replaced with an equivalent sheet material fastened as a bracing element. A key part of remedial work will be to check the original bracing schedule for the building.

Although not essential, it is highly recommended that any other severely damaged plaster board wall sheets are replaced and installed as if they were bracing elements with fastenings as described in GIB® bracing publications. This will provide additional stiffening of the building structure.
