Post-Earthquake Performance of Sheet Bracing Systems

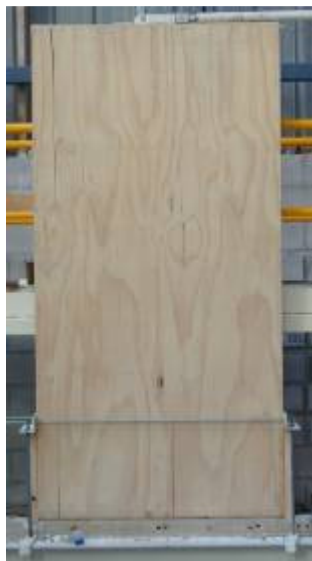
Plate 1

Plywood Bracing Element

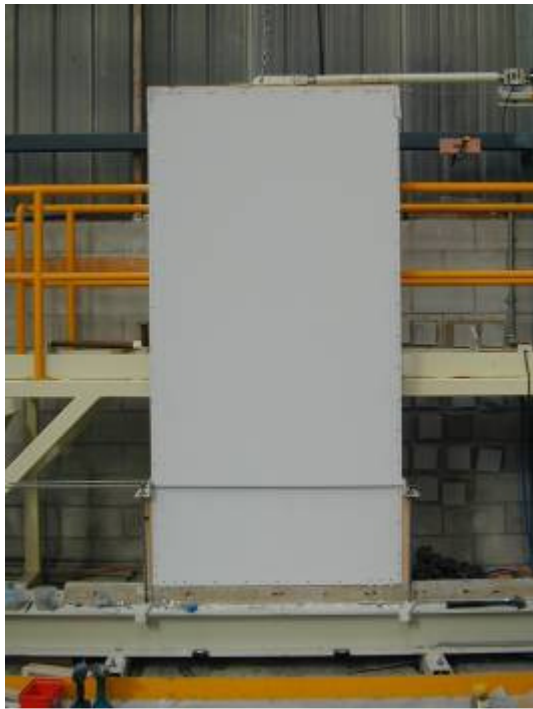
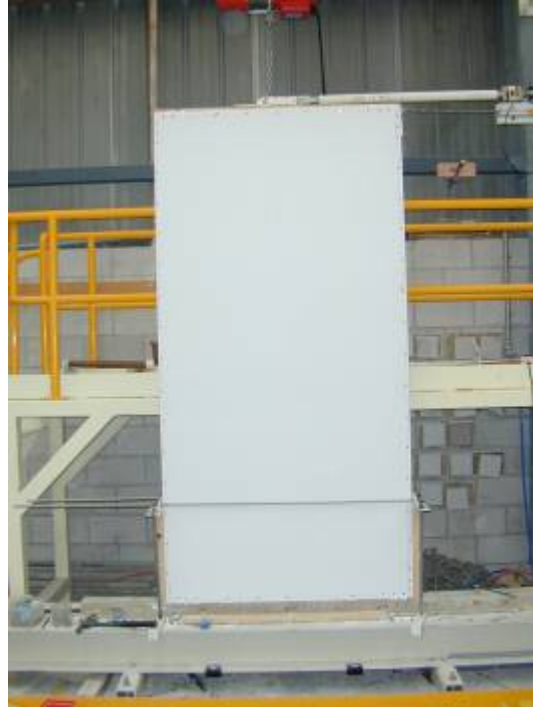
Plate 10

Typical Overlaid Bracing Element Before and After Testing

Little damage to the overlaid sheets was observed after testing. The only damage was concentrated towards the bottom of the elements.

In order to ascertain whether it would be feasible to overlay, a series of tests were undertaken. In the tests, a second layer of 10 mm thick GIB[®] Standard was overlaid the damaged lining. This new lining was fixed with 41 mm long by 6 gauge screws. The screws were slightly offset from the original bracing pattern to insure they did not interfere with the existing fasteners below.
