DESIGN ESSENTIALS FOR CONTROLLING MOVEMENT INDUCED STRESSES IN BUILDING MATERIALS

1. INTRODUCTION

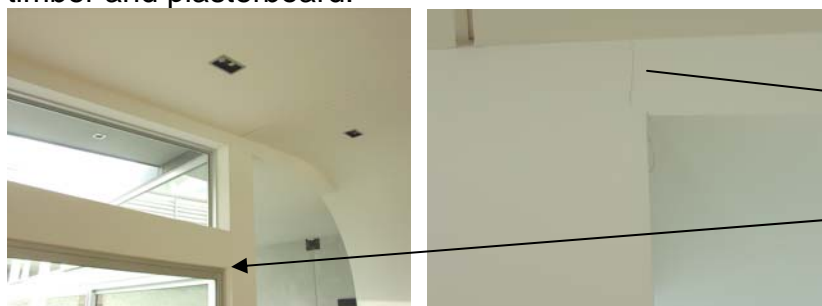
But beware, there's one trap you can fall into when applying plasterboard to timber framing fixed onto a structural steel beam or column. Beware of the differential movement between the steel, timber and plasterboard.

Cracking of board due to underlying differential movement

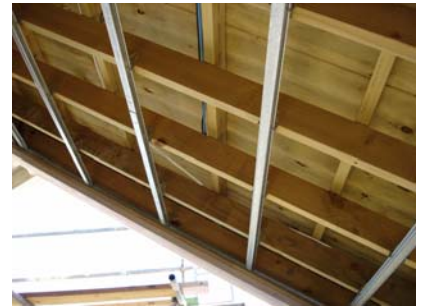
Raked Ceilings

- Metal Ceiling battens fixed at maximum 600mm centres with clips. This method gives a degree of separation between timber structure and the plasterboard diaphragm.
- 13mm Plasterboard for enhanced stiffness and improved quality of finish
- Perimeter relief

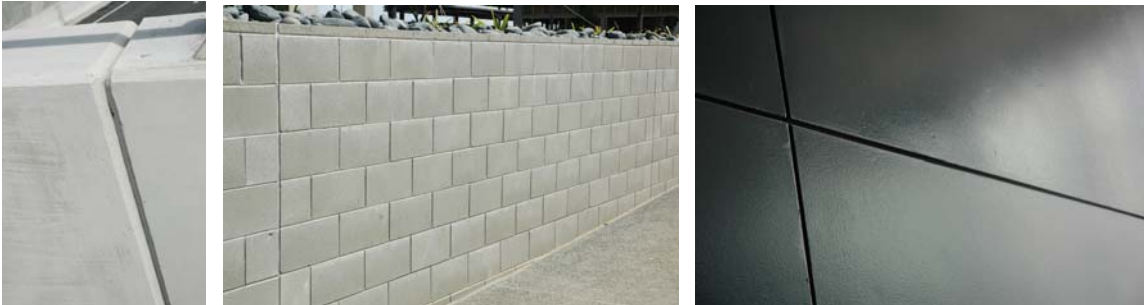
We commonly see the application of control joints in concrete, concrete masonry or fibre cement sheet but not in plasterboard linings. Why Not? The same theories apply for large runs or areas of *any building material*, including plasterboard or fibrous plaster sheeting. Control joints are also required where differing structural materials abut each other such as steel/concrete or timber/fibre cement or brick/fibre cement etc.

Masonry Junction Timber Frame

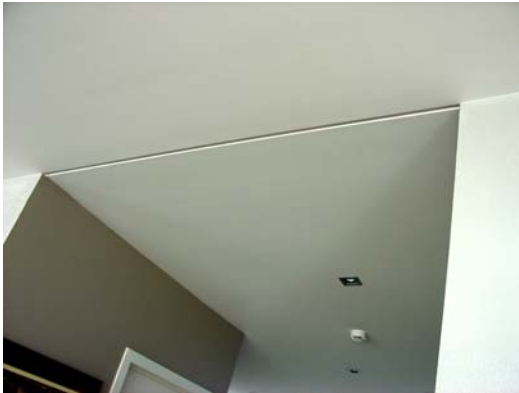
Insert Control Joints in ceilings at junctions of hallways and large open spaces
