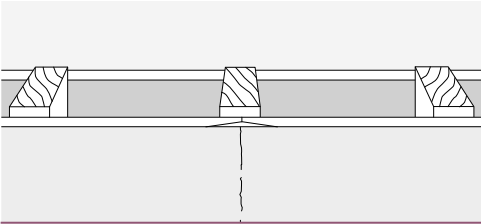
Blisters in Tape	
Description <ul style="list-style-type: none"> — Bubbles appear in areas of the paper jointing tape (ranging in size from approximately 10mm to 40mm, or more) 	Remedy <ul style="list-style-type: none"> — Slit tape to open up blistered area — Fill out with compound, then press tape back in place with broad-knife — When dry, smooth to level finish
Cause <ul style="list-style-type: none"> — Insufficient compound used under tape — Tape not initially pressed into good contact with compound — Too much compound forced from under tape by excessive tool pressure when embedding — Not enough compound in recess — Compound gauge is too dry 	Prevention <ul style="list-style-type: none"> — Provide sufficient compound under entire tape – 0.8mm
Centre Cracking	
Description <ul style="list-style-type: none"> — Cracks appear in the joint down the centre of the joint tape

Remedy <p>Relieve stress, i.e. providing adequate isolation by installing a control joint and re-taping, then feathering compound over broad area to disguise build-up</p>

Cause <ul style="list-style-type: none"> — Abnormal stress build-up resulting from structural deflection or racking — Excessive stresses resulting from hygrometric and/or thermal expansion and contraction 	Prevention <ul style="list-style-type: none"> — Correct unsatisfactory environmental conditions — Provide sufficient relief and re-tape — Provide proper isolation from structure to prevent stress build-up — Provide adequate control joints — Structurally brace underlying framing — Ensure moisture content of timber is 18% or less

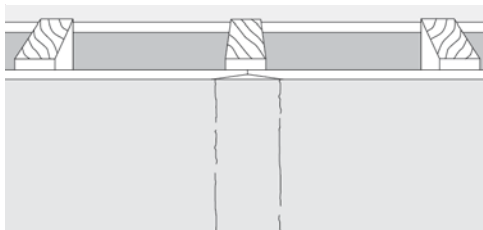
Edge Cracking

- Cracks at edge of GIB® tape or GIB® Goldline® trims

- Remove all poorly bonded tape, then reapply compound and tape in correct manner

- Fast drying of taping compound due to high temperature and low humidity, or excessive drafts
- Improper application, e.g. over-dilution of compound, use of wrong compound, or no second coat over tape
- Cold, wet application conditions (also causes poor bond)

- In hot, dry conditions, use GIB Tradeset® 45
- In extreme conditions use a multi-purpose air drying compound. Note: these dry rather than set, so provide more open time
- Place shielding devices over room openings to prevent drafts. Do not apply joint treatment over hot surfaces
- During cold weather, control heat at minimum 10°C and supply good ventilation
- Avoid practices listed under "Cause" opposite

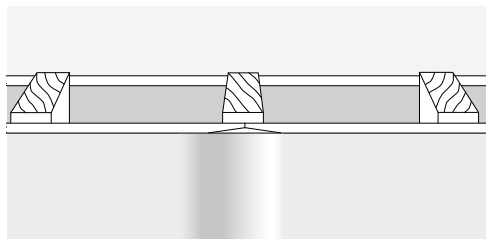
- Joint area is higher than the surrounding plasterboard and may result in shadowing across the joints

- Sand joints to flush surface (take care to avoid scuffing paper or joint tape by over-sanding)

- Excessive compound over joint
- Compound not feathered out beyond shoulders
- Improper bedding of tape
- Framing out of alignment or sheet edges not tight against framing
- Improper adjustment of mechanical tools
- Misuse of, or worn, tools

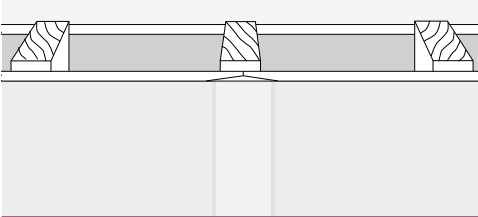
- Shrinkage of the joint adjacent to the paper tape. Looks like the tape is visible on the joint

- Lightly sand affected areas
- Apply a skim coat to the joint with an air drying compound, and sand and decorate

- The first coat of compound is not sufficiently dry before the second coat is applied. When the first coat dries it shrinks and pulls the tape back into the joint
- The second and top coat are too thin
- Compound is too thin or watery
- Inadequate drying between coats
- Poor drying conditions
- Slow drying due to excessive filling in one coat
- Premature paint application

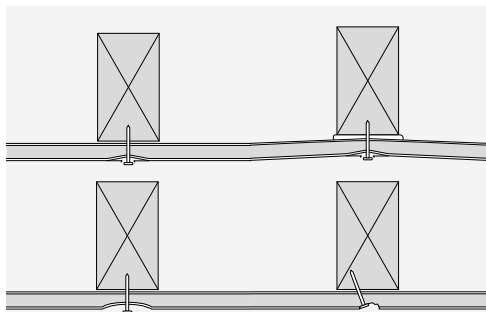
- Protrusions or bumps directly over the nail/screw head
- Rupture of the surface around nail/screw head
- Looks like nail/screw head protruding above the surface of the board

- Timber shrinkage (timber shrinks as it dries, causing the fastener to protrude). Nail/screw pops may not become apparent for some considerable time after installation
- Fixing through glue – if screws or nails are applied through adhesive, a pop can occur as the glue dries and shrinks back; pulling the plasterboard closer to the framing member
- Plasterboard not held in close contact with the framing members. If the plasterboard is not held firmly against the stud while fixing, it increases the possibility of over-driving the nail (resulting in a blister-like defect the size of the hammerhead)
- Overdriven or skewed nails/screws can puncture the face paper, which results in no holding power
- Air trapped between the fixture and the compound, when the compound is placed
- Nail heads/screw heads puncturing face paper

- Nail pops that occur after at least one month's heating cycle are probably caused by timber shrinkage. Because further shrinkage is likely to occur and pops reappear, do not repair until the end of a heating season
- A screw should be reapplied 50mm from the popped fastener. Drive in a new fastener whilst applying firm pressure, to ensure firm contact with framing. Use a nail punch to seat the popped fastener beneath the surface of the plasterboard
- Remove compound. Apply two coats of setting compound followed by an air dry compound coat, then redecorate

- Avoid timber shrinkage by using GIB® Rondo® metal ceiling battens for ceilings or kiln dried timber. Close in the building and protect the framing from the elements as soon as possible. Ensure that timber moisture content is 18% or less at the time of lining. Use of steel battens for large ceiling areas will eliminate shrinkage factors

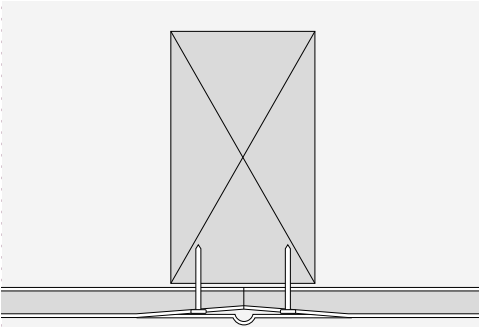
- A condition where joints are visible under critical lighting
- More prevalent when board has been installed in cold weather
- Often called ridging or beading
- Looks like a continuous ridge along the length of the joint, with a uniform peak-like pattern at the centre
- Commonly occurs in conjunction with 'nail popping'

- Ridges must only be repaired after a full heating cycle (6 months to a year). Mid-summer is generally the best time for rectifications
- Apply a coat of setting compound over the joints using a 300mm trowel to widen the joint. Scrape back and apply a light coat of a topping coat. Reseal affected area. Examine the surface with harsh lighting to determine whether the ridge has been concealed. If all right, then decorate

- Excessive gaps (i.e. over 2mm) left between sheets
- Timber movement due to excessive moisture content of timber at time of lining and subsequently drying out. This is more prevalent with 10mm plasterboard than thicker plasterboards
- No gaps at the base of wall sheets. This can cause pressure on the base of the sheets thus transferring tension to the joints
- Inadequate ventilation with concrete floor slabs, resulting in a build-up of water vapour

- Use GIB® Rondo® metal ceiling battens on ceilings
- Ensure timber framing moisture content is 18% or less at time of lining
- Use a back blocking system on ceilings
- Gaps between sheets should be pre-filled with a setting compound and allowed to completely dry before application of tape and subsequent coats of compound
- Always allow a 5mm-10mm gap at the base of wall sheets to allow for shrinkage of the wall plates and studs
- Ensure compound materials are maintained at a minimum temperature of 10°C during, and following, installation. Allow adequate ventilation

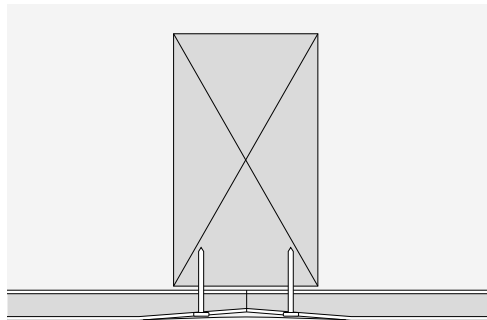
- Compound shrinking back when it dries, causing a depression at the joint or on a fastener
- Looks like depressions at the joint

- Lightly sand affected areas and apply air drying compound, then sand (using 220 grit or finer sand paper)
- Seal repaired areas and then re-decorate

- Compound too thin or watery
- Inadequate drying between coats
- Slow drying due to excessive filling in one coat
- Under slow drying conditions, joints and plasterboard may hold moisture for weeks

- Provide proper drying conditions for compound. The two setting coats must be thoroughly dry prior to top coating. The top coat must be thoroughly dry prior to application of sealer
- Use compound at heaviest workable consistency and allow to stand for 2–3 minutes before applying
- In slow drying conditions apply a number of thinner coats rather than a few thick coats
- Under slow drying conditions use shorter set time joint compounds
- Allow joint compound to fully dry between coats

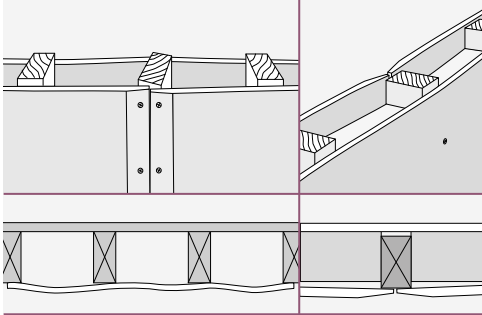
- Plasterboards are not flat but have a bowed, dished or undulating surface
- Studs or ceiling joists not on the same plane as other framing members
- A twisted framing member
- Shadows being cast across the joint
- Plasterboard forced into place

- Framing oversights
- Framing out of alignment with adjacent framing, making it difficult to bring the sheet into firm contact with framing members
- Excessive moisture in the timber framing can also cause warping, twisting or bowing as it dries
- Fixing the perimeter of the sheet prior to the centre
- Fixing of damp plasterboard
- Excessive loading from insulation or light fittings causing too much weight on plasterboard
- Incorrect placement of vapour barrier causing moisture build-up within the plasterboard
- Exceeding maximum span of fasteners when fixing
- Not allowing a 5mm–10mm gap between the floor and the plasterboard
- Incorrect fastening sequence for lining light gauge steel framing
- High temperatures in the ceiling space causing board expansion, particularly in skillion roofs with poor ventilation
- Incorrect storage – storing of plasterboard on edge on damp concrete floors

- It is extremely difficult to rectify some of these problems without having to resort to full replacement of the linings after rectifying underlying factors
- Replace all warped or crooked studs
