Weatherline Fire Test

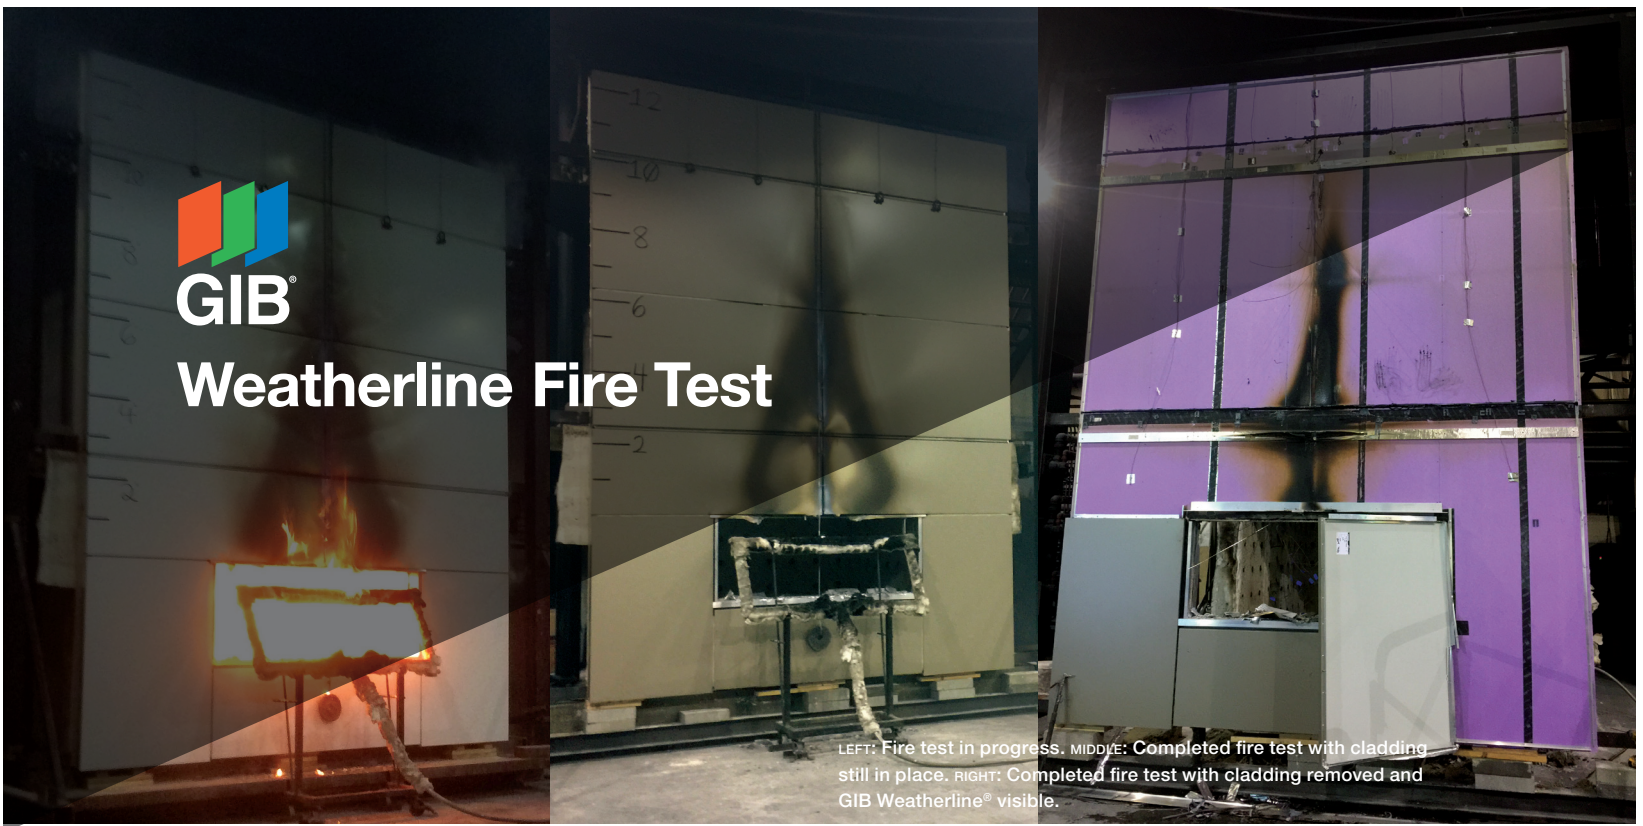
LEFT: Fire test in progress. MIDDLE: Completed fire test with cladding still in place. RIGHT: Completed fire test with cladding removed and GIB Weatherline® visible.

In proprietary tests undertaken by two reputable international cladding manufacturers and their respective New Zealand Distributors, GIB Weatherline® was included in combination with claddings to pass two separate NFPA285 full scale Façade fire tests.

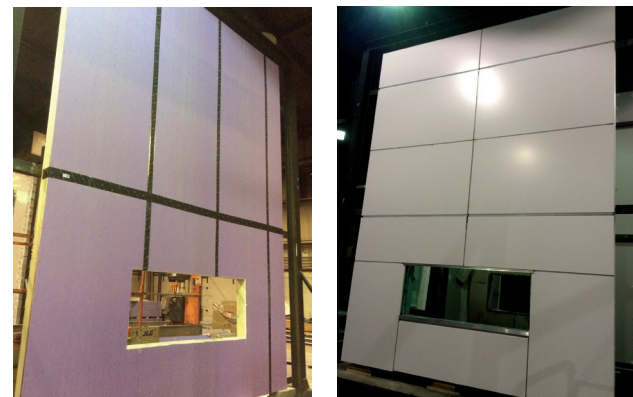
ABOVE: Preparation for the fire test with GIB Weatherline® lining (left) and with cladding (right).

However, to meet High Risk Applications MBIE protocol P3, 13mm GIB Weatherline® Rigid Air Barrier was tested

on timber framing with internal insulation in two separate NFPA 285 full scale façade tests in combination with both Alucabond and Reynoldual claddings systems..
